# Investigating the Underwater Archaeological potential of the Danish Trade Monopoly Period – Grundarfjörður Trade Port 2023

Results of a side-scan sonar survey and target inspection

Report author: Dr Kevin Martin  
Minjastofnun Íslands rannsóknarleyfið: 202303-0133  
Survey No: 3169  
November 2023

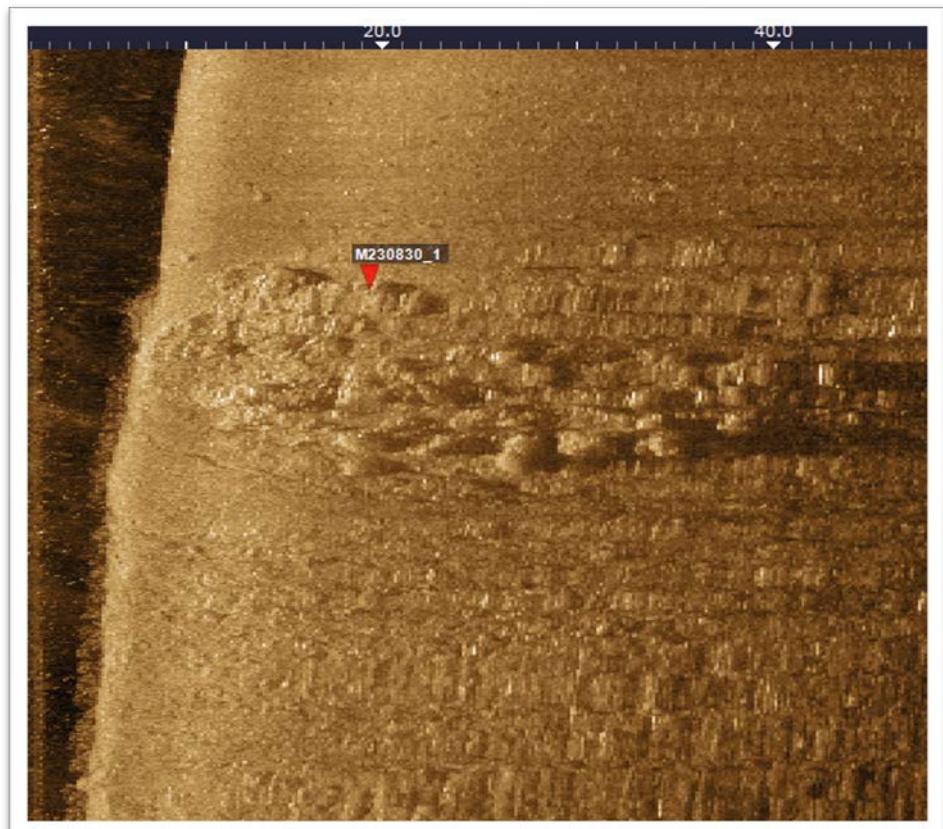
Figure 9. Close up sonar image of target M230830\_1

M230830_1	20x40	12	Rock ridge, geological feature	Y, Dive 1	64° 56.037'N, 23° 12.905'W
M230830_2	5x5	8	Rock outcrop		64° 56.008'N, 23° 12.859'W
M230831_1	15x3	11	Rock ridge		64° 55.667'N, 23° 15.201'W
M230831_2	20x10	13	Area with multiple unknown objects on the seabed	Recommended in future project	64° 56.578'N, 23° 13.300'W
M230831_3	9x5	14	Unknown object, with angular forms, may be part of a wreck	Recommended in future project	64° 55.731'N, 23° 15.286'W
M230831_4	20x8	11	Area with a number of unknown targets		64° 56.528'N, 23° 13.306'W
M230831_5	21x4	12	Linear alignment of several unknown objects		64° 56.527'N, 23° 13.316'W
M230831_6	6.5x5	5	Rock outcrop, or poss. Cultural feature.		64° 56.564'N, 23° 13.306'W
M230831_7	26x0.5	23	Unknown linear object, possibly chain or pipe	Recommended in future project	64° 55.922'N, 23° 14.099'W
M230831_8	20x1.5	8	Linear feature, possibly cultural	Recommended in future project	64° 56.202'N, 23° 12.973'W

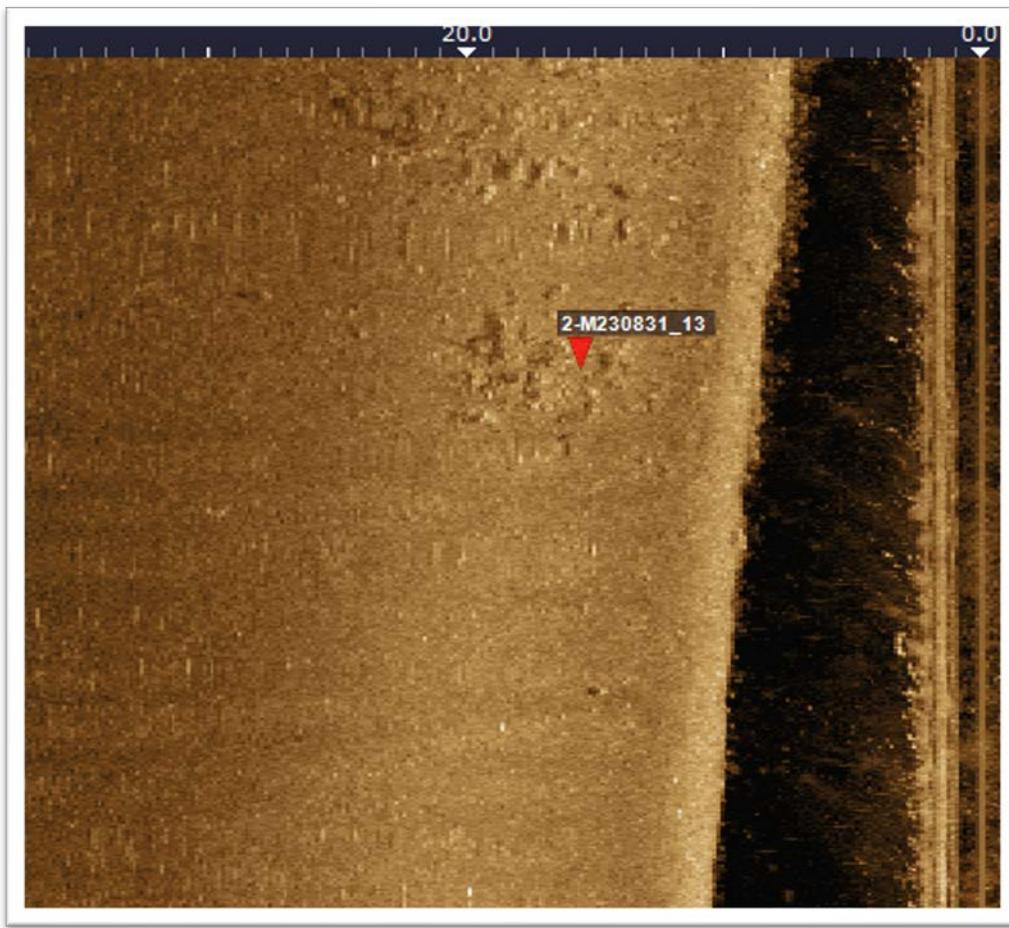
Figure 10. Close up of sonar target M230831\_13

M230831_12	8x8	20	Possibly frames from a shipwreck?	Recommended in future project	64° 55.837'N, 23° 13.732'W
M230831_13	10x10	12	Possible ballast mound / Rock outcrop	Y, Dive 1	64° 56.069'N, 23° 12.927'W
M230831_14	10x6	5	Possible ballast mound / natural bed rock outcrop	Y, Dive 2	64° 55.400'N, 23° 14.664'W
M230831_15	15x10	4	Unknown large feature likely natural rock outcrop		64° 55.359'N, 23° 14.413'W
M230831_16	8x10	8	Rock outcrop		64° 55.915'N, 23° 12.817'W
M230831_17	10x10	9	Rock outcrop	Y, Dive 1	64° 56.048'N, 23° 12.899'W
M230831_18	5x5	11	Rock outcrop	Y, Dive 1	64° 56.069'N, 23° 12.915'W
M230831_19	7x6	11	Rock outcrop	Y, Dive 1	64° 56.065'N, 23° 12.923'W
M230831_20	40x35	8	Large rock outcrop	Y, Dive 1	64° 56.046'N, 23° 12.897'W
M230831_21	12x2	9	Prominent unknown object	Recommended in future project	64° 56.018'N, 23° 12.879'W
M230831_22	10x10	11		Y, Dive 1	64° 56.042'N, 23° 12.904'W
M230831_23	25x10	6	Prominent unknown object	Recommended in future project	64° 55.409'N, 23° 14.095'W

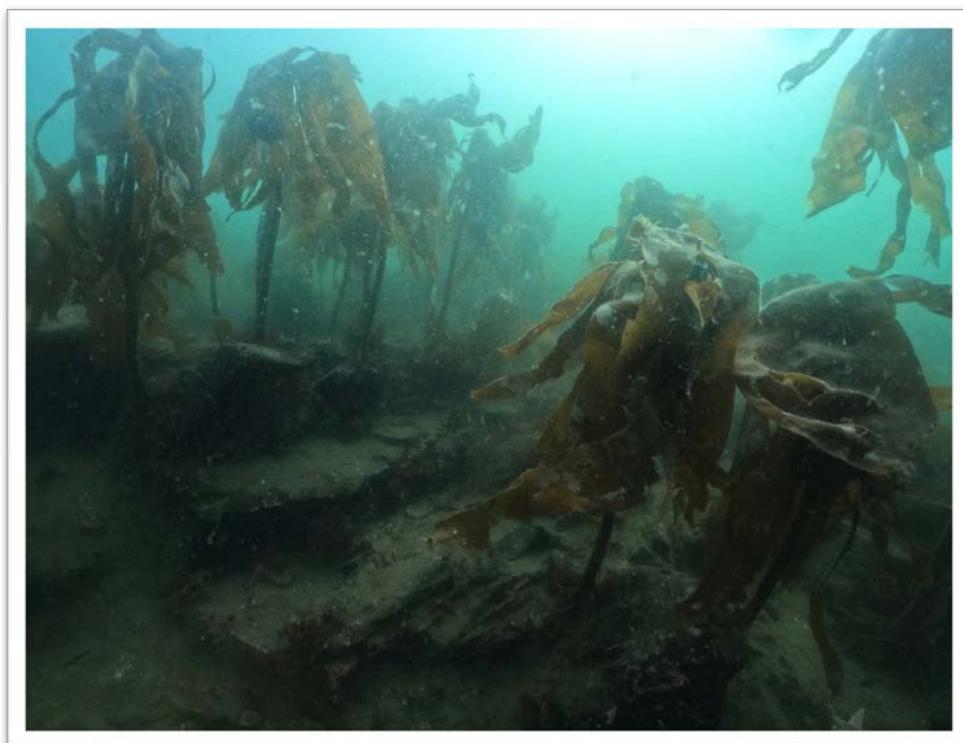
Dive 1 was organised so that two marine archaeologists (Dr Kevin Martin & Dr Philipp Grassel) were dropped together into the water directly over target M230831\_13 from where they swam south underwater towards target M230830\_1 where they were retrieved by the surface support vessel after completing their dive. The purpose of the dive in addition to the specific target examination was to get a general sense of the bottom composition and sedimentation of the seabed and to access visibility and currents in the water. All 7 targets inspected on this dive comprised natural geological features mostly consisting of bedrock outcrops from the seabed with kelp growth (Figures 8-18). No archaeological features or deposits of cultural heritage were identified during the dive.

*Figure 15. Kelp and bedrock outcrops observed during Dive 1 (KM 2023)*

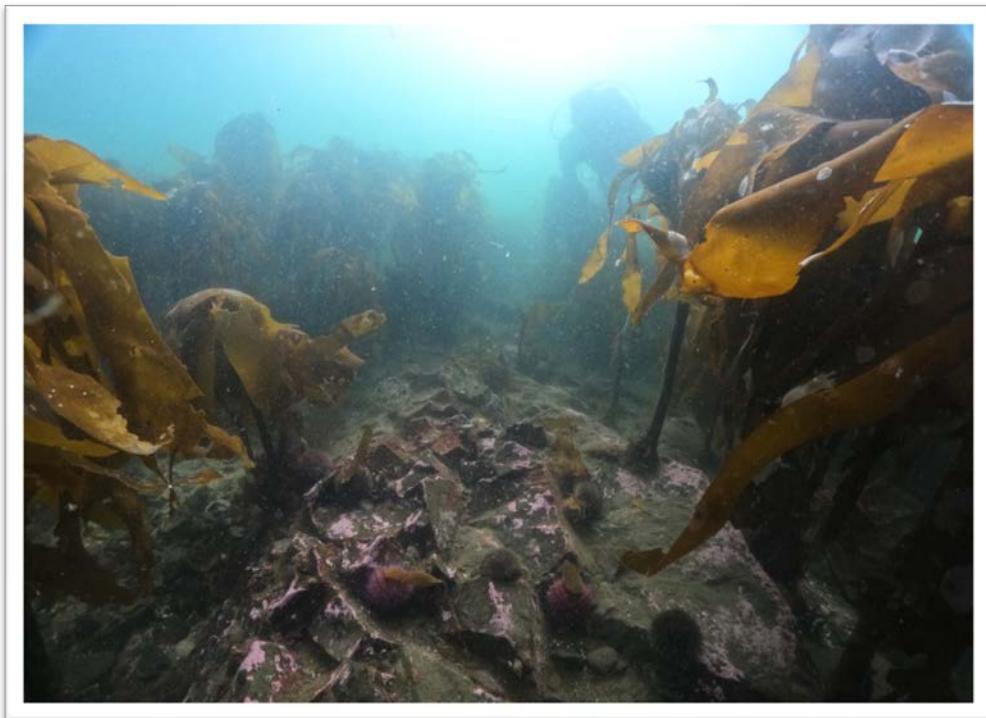
Figure 16. Bedrock outcrop with kelp growing from it observed during Dive 1 (KM 2023)

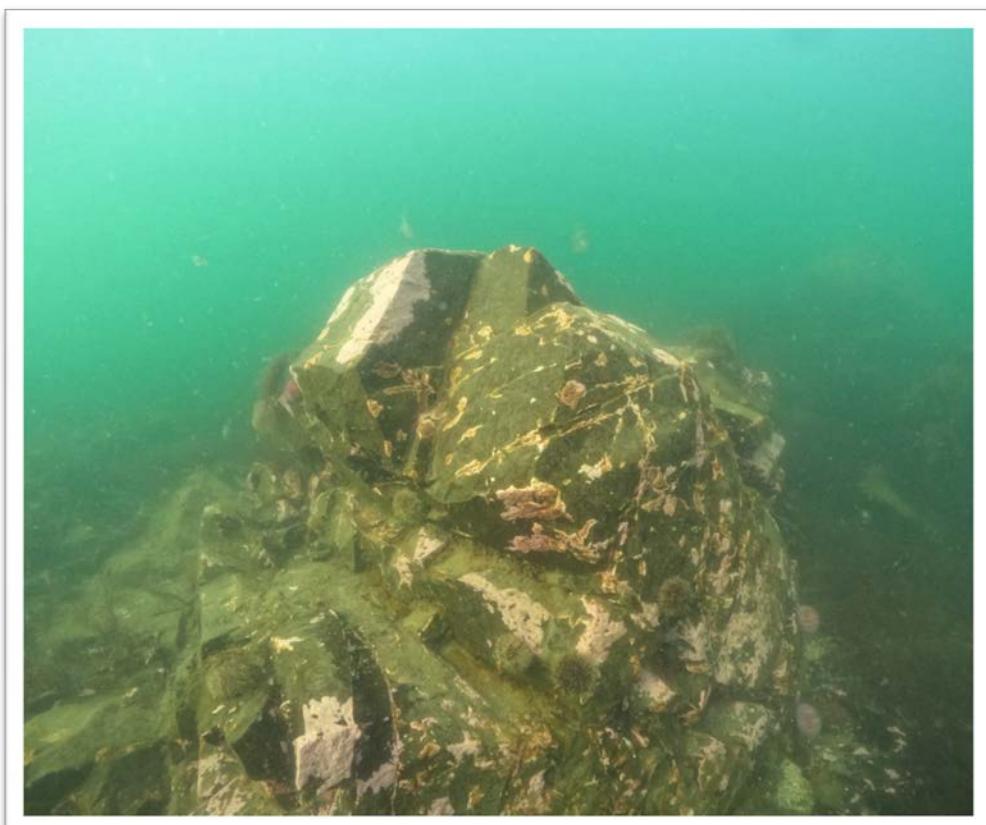
Figure 17. Bedrock pinnacle observed during Dive 1 (KM 2023)

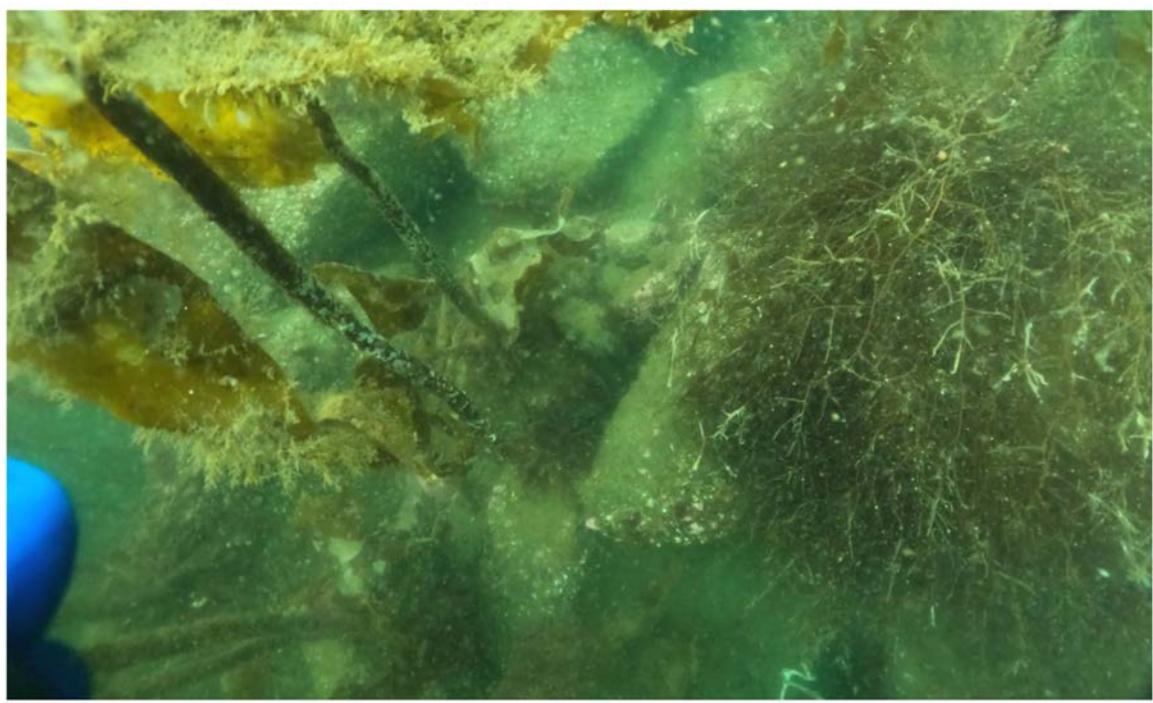
Dive 2 was located in an area in close proximity to the modern harbour of Grundarfjörður approximately 100m east of the modern breakwater and boat harbour. There was an underwater visibility in this area of approximately 3m which was noticeably poorer than that experienced during Dive 1. The area also featured more traces of modern garbage on the seabed than was observed previously. However, this was not too surprising given its closer proximity to the modern harbour. Two targets were inspected during this dive: M230831\_11, M230831\_14 (Figures 19-22). The targets were 22m apart from each other. The seabed in this area was quite compact in places and comprised of compact small stones with almost no silt deposits evident. Where they were present the silt was not deeper than 20cm. The marine archaeologists descended a shot line directly onto Target M230831\_11 and once inspected swam southeast to target M230831\_14. M230831\_11 comprised a mound of large boulders (1-1.5m in diameter) with mixed inclusions of modern material including concrete blocks and iron rods. It's likely the boulders and associated material were dumped here during the construction of the breakwater. M230831\_14 was initially considered to possibly have represented a ballast mound but on inspection was of similar composition to target M230831\_11 and likely represented the same origins (dumped material during the construction of the nearby breakwater). No cultural heritage features or deposits were evident around these targets.

Figure 21. Photo of target M230831\_11 mound of boulders, modern material (KM 2023)

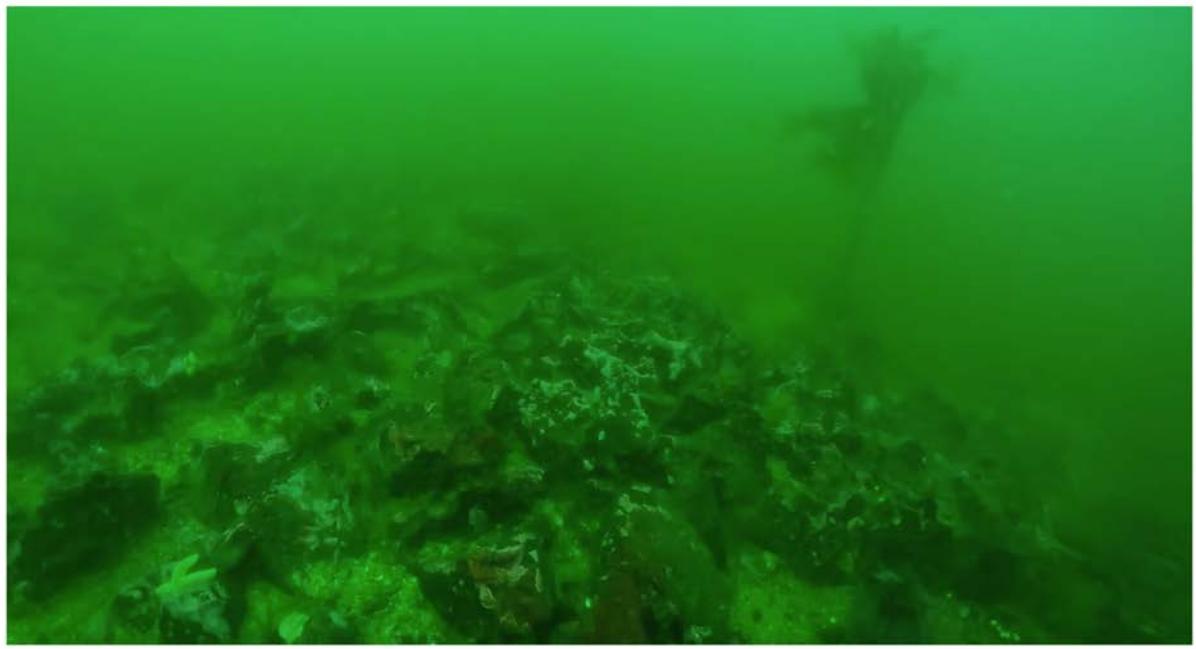
M230829_16	9x4	16.5	Linear rock outcrop. Likely natural.		64° 56.478'N, 23° 13.657'W
M230829_17	10x4	14.5	Rock ridge, likely natural geological feature		64° 56.652'N, 23° 13.347'W
M230829_18	10x4	6	Kelp forest?		64° 56.998'N, 23° 12.654'W
M230829_19	10x4	6	Kelp forest?		64° 56.986'N, 23° 12.682'W
M230829_20	50x4	14	Linear feature / geological feature	Y, Dive 3	64° 56.629'N, 23° 12.302'W

Figure 25. Natural ridge of bedrock identified at Target M230829\_20 (JL 2023)

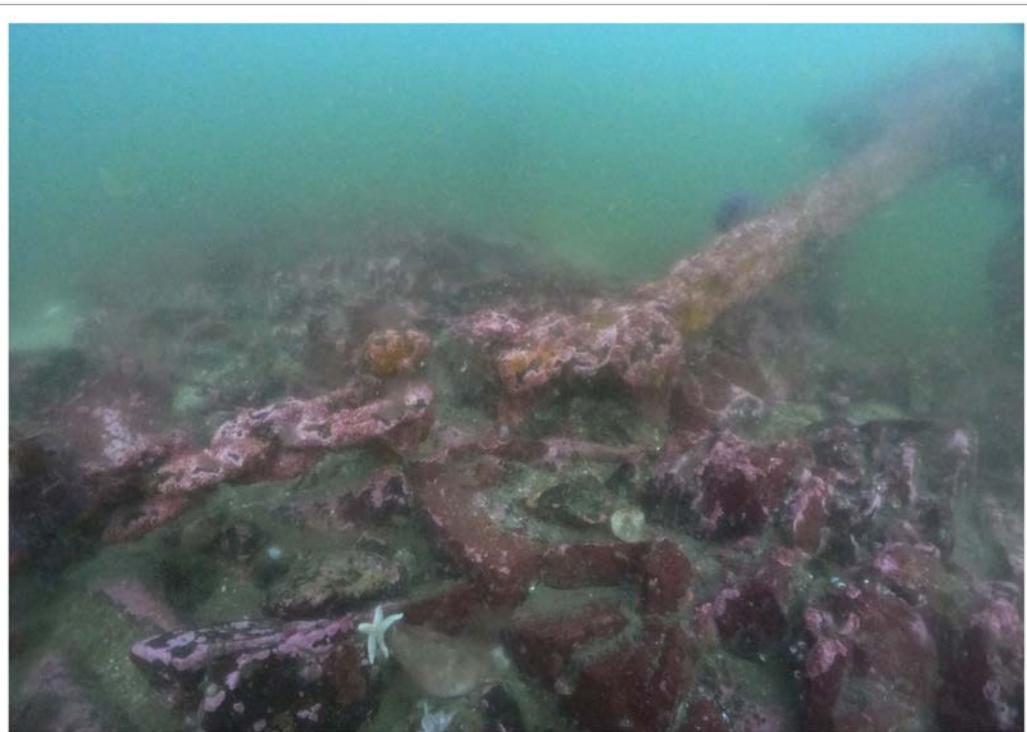
Overall, the anchor was in reasonably good condition showing little signs of heavy corrosion or deterioration. The iron chain which was attached was more noticeably corroded than the anchor. The anchor lay directly on top of a rocky outcrop, resting upright on its flukes and was not deeply set into the seabed. All the main components of the anchor were present including flukes, shank, crown and ring. The shank was measured at 1.5m long and 0.2m thick and the flukes were approximately 0.6m high.

Figure 28. Chain and anchor ring resting on top of natural bedrock (JL 2023)

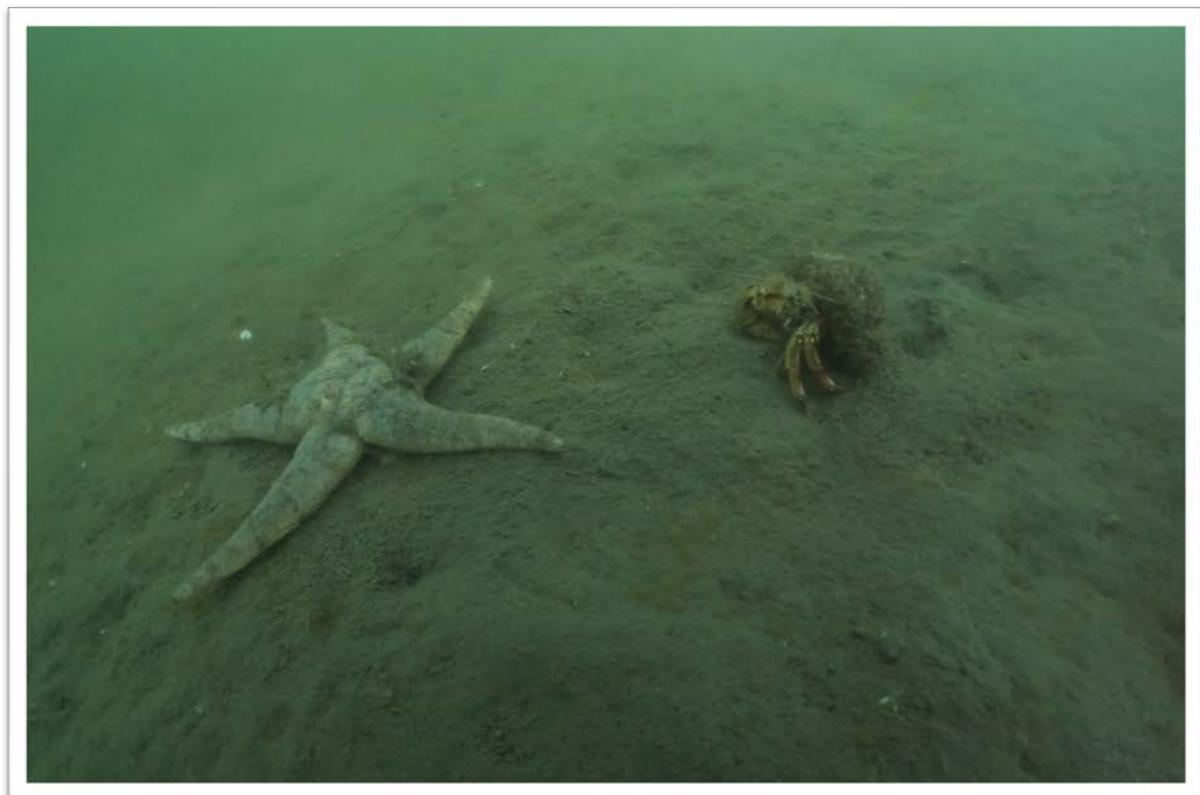
Dive 4 focussed on the area of the bay where gravel extraction works from the seabed had occurred during the mid-20<sup>th</sup> century. The project team had been informed by the harbour master that remains of a historic wreck had been uncovered there during gravel extraction works in the 1960's. The location was also directly in the vicinity of a known historical anchorage which was seen on a French navigational chart from 1888 (Figure 31). The anchorage is also shown on the modern Navionics chart for the bay (Figure 32). The gravel extraction pits were situated in the south eastern part of the survey area approximately 300m west of the shoreline in a depth of 20m. The visibility during the dive was limited to 2-3m and the bottom composition was a mixture of gravel under a 20-30cm layer of loose fine silt/sediment (Figure 33). The divers descended into a number of steeply sloped pits which were approximately 4-5m deep but visibility was extremely limited once any bottom sediments were disturbed. They swam over an area measuring 40m x 50m examining a number of these pits but no cultural heritage features or deposits were evident.

Figure 33. Seabed bottom around the area of the gravel extraction pits during Dive 4 (JL 2023)

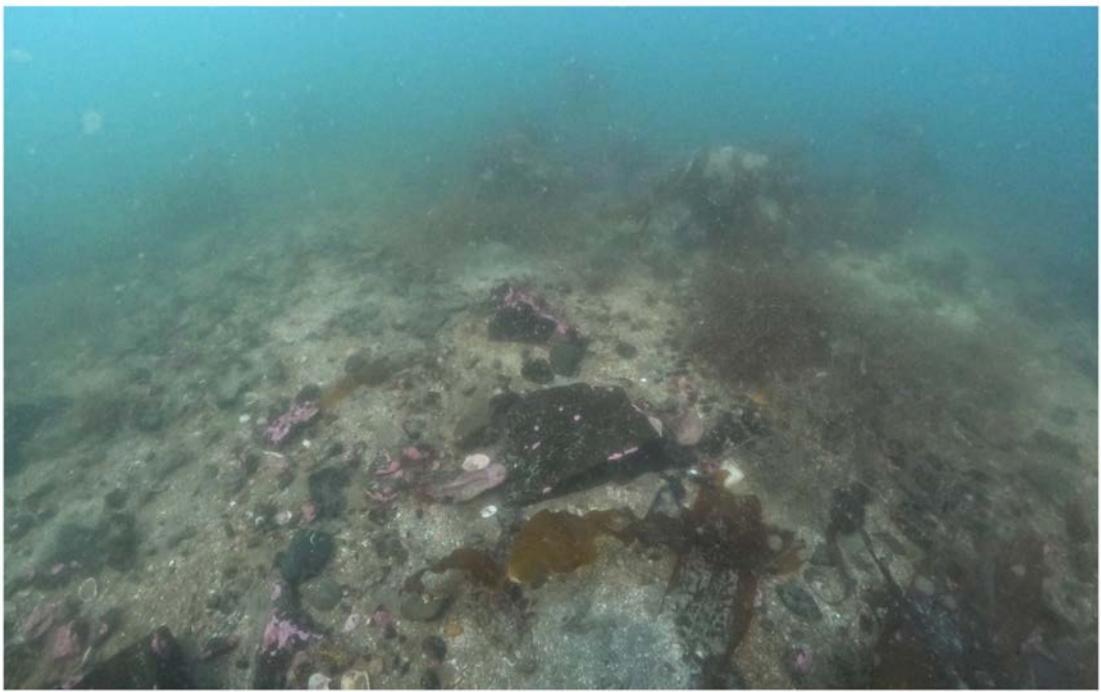
Dive 5 was located close to the eastern extent of the area of Dive 1 and was selected as a dive target based on a position marked at this approximate location on the modern navigational charts (Navionics) indicating the presence of a wreck site (Figure 34). It was also in the general area of a known historic anchorage position marked on a French navigational chart of Grundarfjörður from 1888 which the archaeological team had examined previously at a museum in the town. The depth in this area was 20m and a recorded visibility of 5m. The seabed composition in this area was a mixture of bedrock with patches of compact gravel, silt and sediment (Figure 35). A circular search was conducted but no evidence of a wreck or other cultural heritage features or deposits were evident during this dive.

*Figure 35. Seabed composition observed on Dive 5 (KM 2023)*
