DEILISKRÁNING FORNLEIFA Á ÓSI Á SKÓGARSTRÖND

Kevin Martin B.A., M-Phil, PhD Candidate

2019

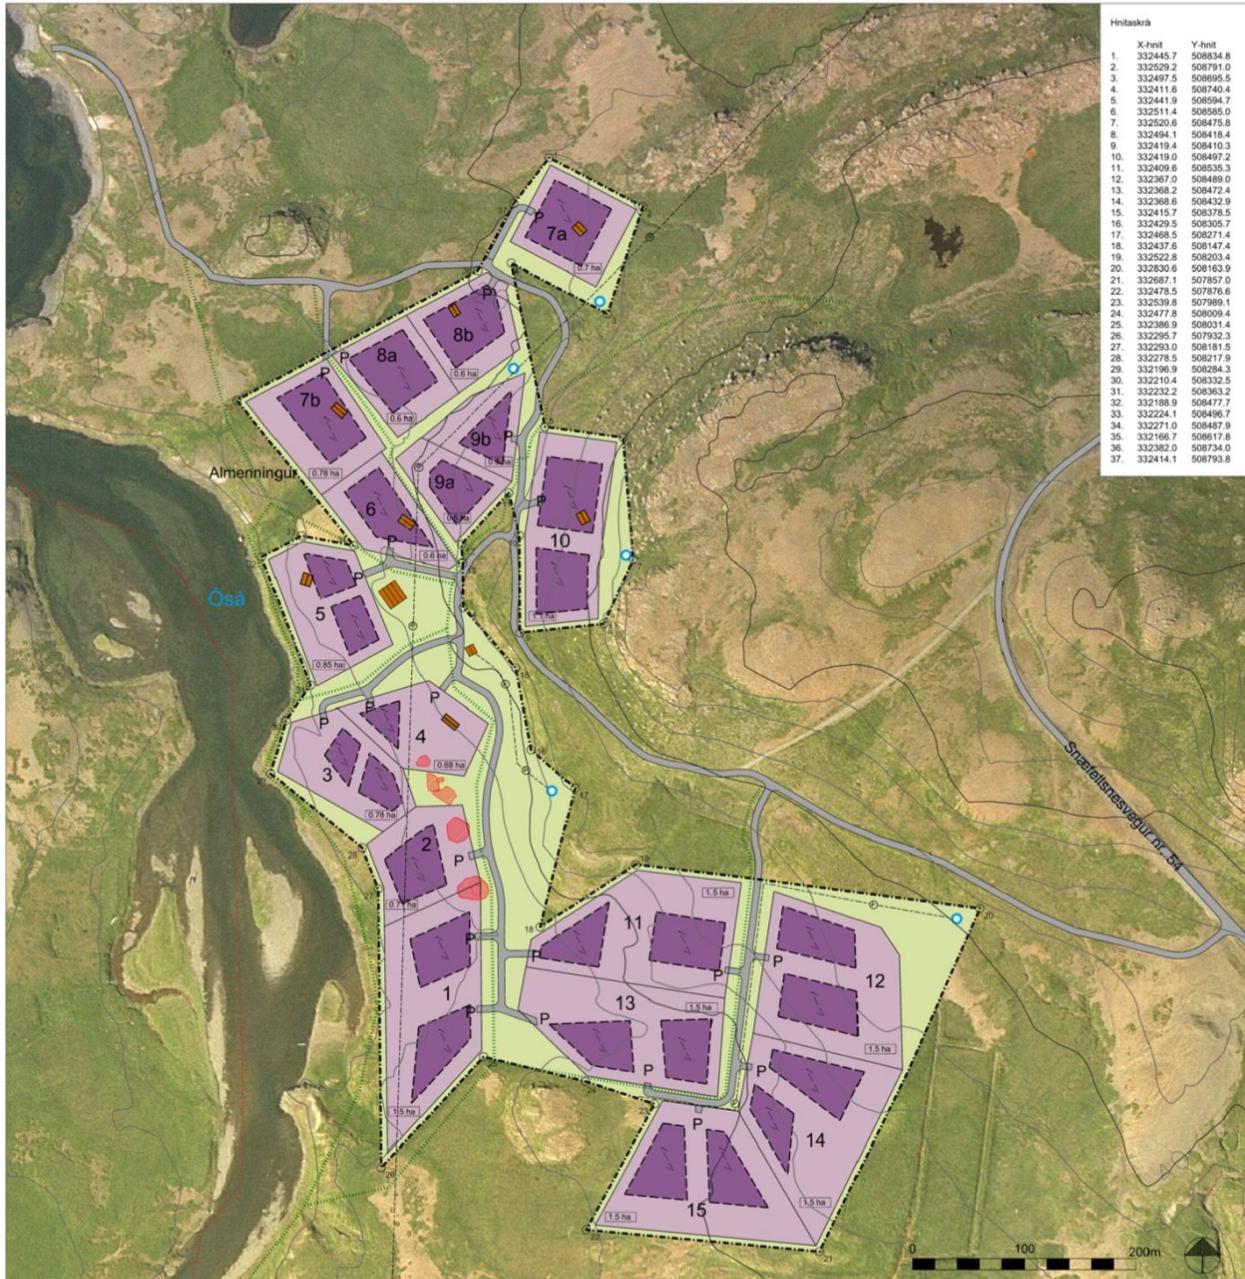
Fig 2. Ós Fristundabyggð - Map of proposed housing plots at Ós farmstead. (Dalabyggð 2019)

An inspection carried out by Minjavörður vesturlands Magnus. A. Sigurðsson back in 2009, resulted in four features of interest being measured at Ós (pers.comm. Magnus. A. Sigurðsson) which are indicated by red polygons on Fig 2. During the 2019 survey, the author planned to inspect the four features of interest previously identified in order to survey them in a higher resolution/accuracy.

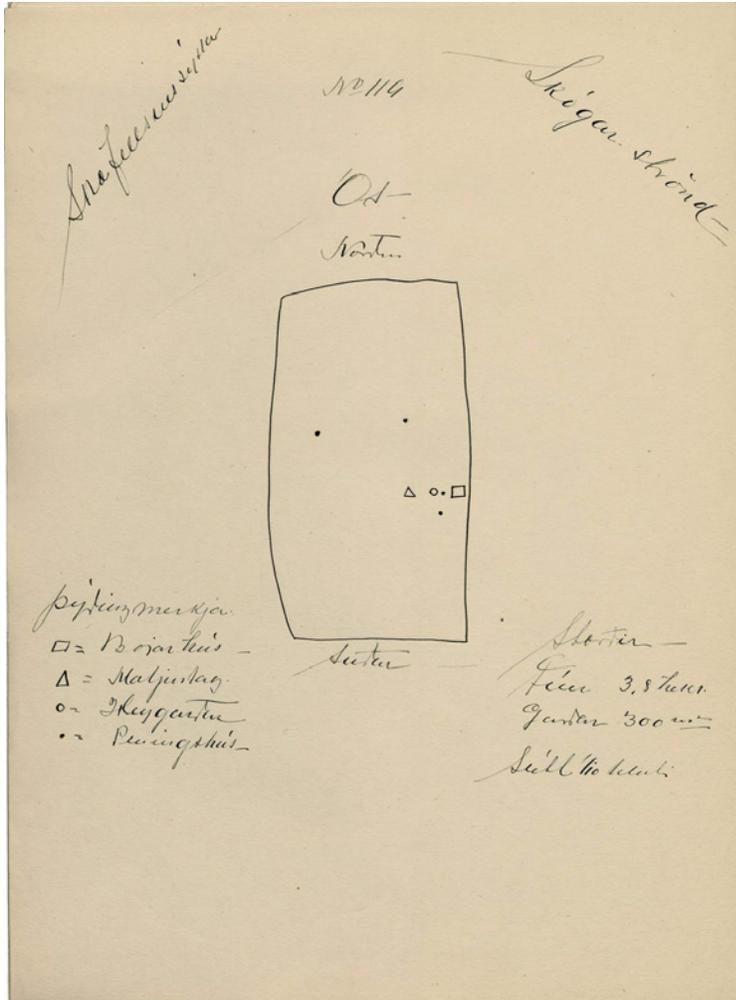
Fig 3. Túnkort of Ós

In 1913 the farm at Ós was mapped and recorded to create the Túnkort (See Fig 3). A number of buildings were recorded on the farm, none of which survive to present day. These included the Bæjarhús and Peningshús. The farmland at Ós was measured as 3.8 hectares in size.

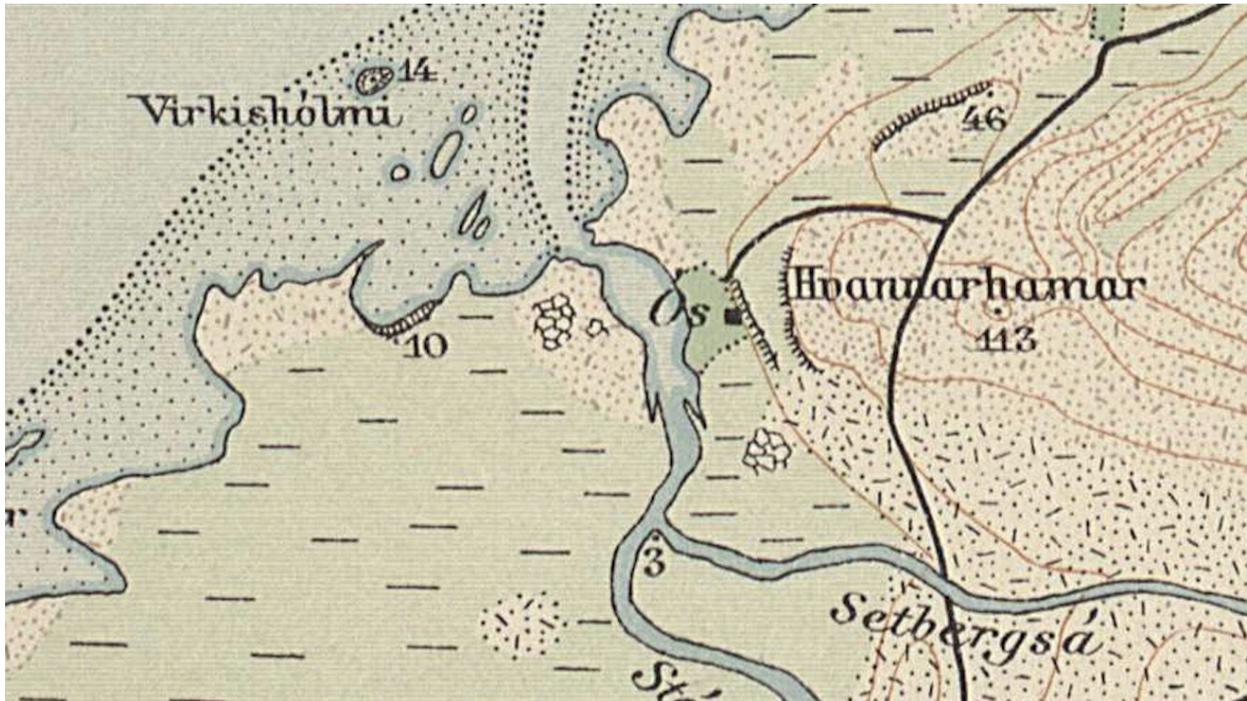
Fig 4. 1913 Generalstabens Topografiske kort of Ós 1:50,000 - (Herforingjaráðskort 1913, 24SV og SA)

The 1913 Generalstabens Topografiske kort shows the farmland area of Ós but no buildings or monuments are marked within the land area. (Fig 4)

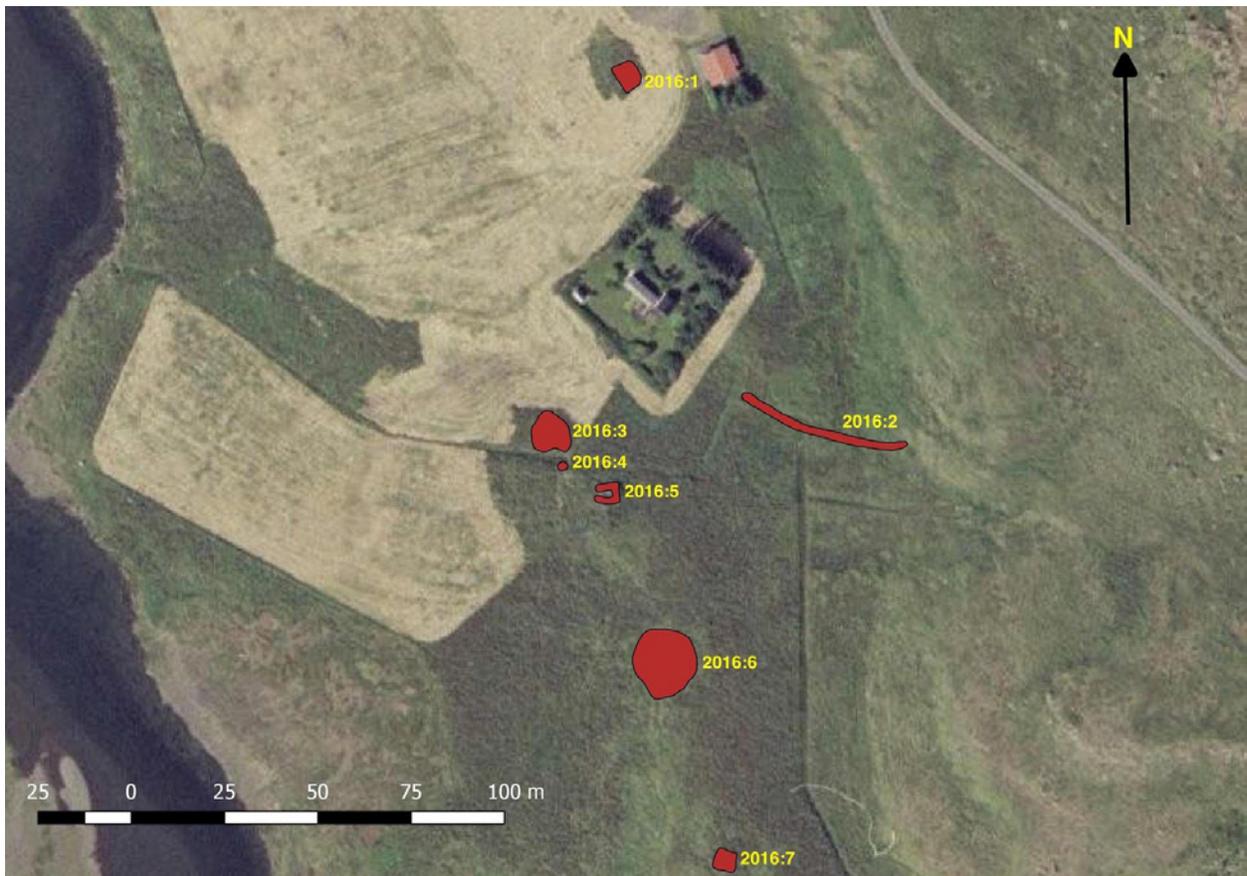
Fig 5. 2019 Archaeological survey of Ós farmstead showing seven features identified (K Martin 2019)

On March 6th 2019, the author field walked the Ós farmstead accompanied by Sigþór Bragason and his uncle who grew up at the farm and remembers it from the 1940's and 50's. The features identified were surveyed using a Trimble GeoXH Geoexplorer 6000 series handheld GPS. The data was later downloaded and exported to a GIS software programme QGIS. Seven potential features of archaeological interest were identified at the farm Ós and a number of these have

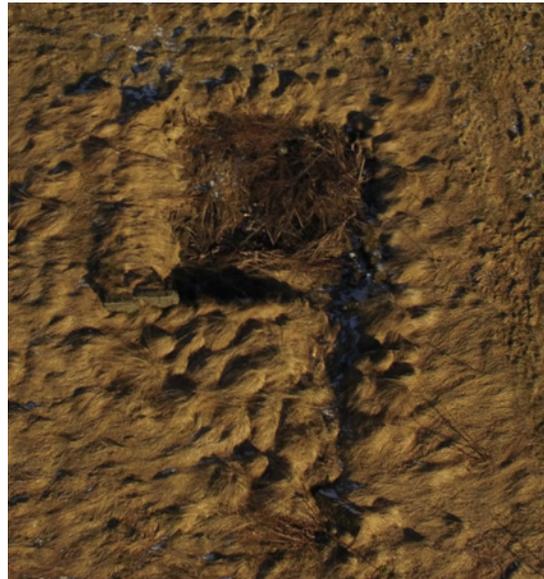
2016:1 - E:332354, N508390

Fig 6. 2016:1 survey with scale (KM 2019)

Fig 7. 2016:1 aerial image (KM 2019)

2016:1 was identified as the foundations of the old farm house which burned down circa 1973. “Grunnur af gamla bænum sem brann ca 1973” - pers. comm. Sigbór Bragason 2019. It measured approximately 7.5m x 6.5m and comprised partially of drystone walls with later additions of concrete walls. The area was quite overgrown and had a lot of vegetation material dumped into it so it wasn't possible to determine if any floor layers were present underneath. It may potentially be related to one of the buildings represented on the 1913 Túnkort of Ós (Fig 3). Therefore its oldest parts may likely be archaeological in nature i.e. date prior to 1919. This feature has medium/high archaeological value.

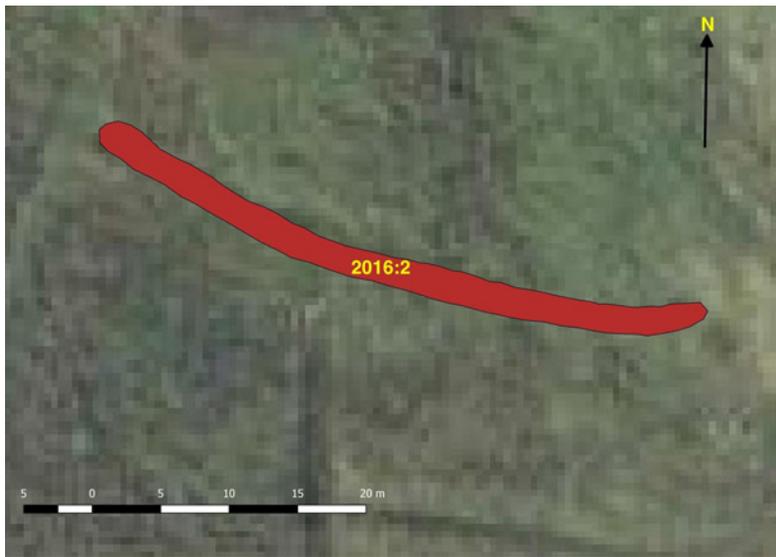
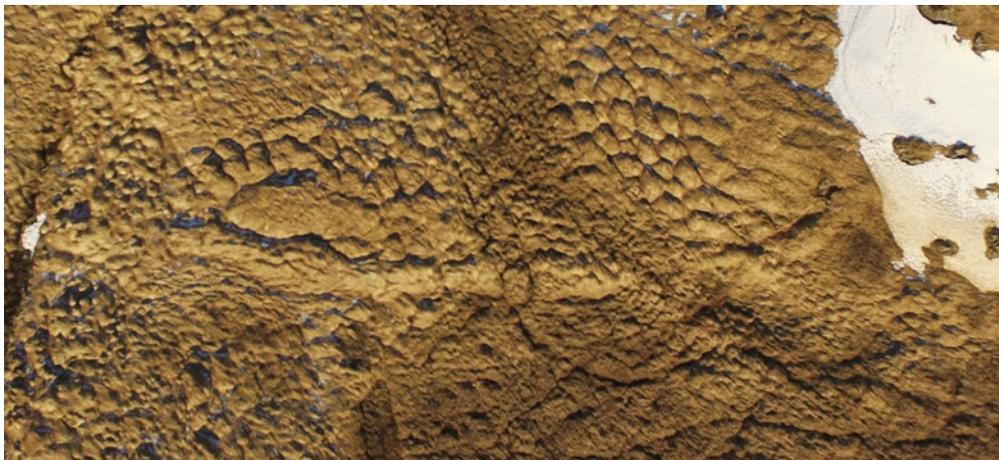
2016:2 - E:332402, N:508295

Fig 8. 2016:2 survey with scale (KM 2019)

Fig 9. 2016:2 aerial image (KM 2019)

2016:2 was identified as a potential field/farm boundary wall. “Leifar afgömlum, túngarði / vegg” - pers. comm. Sigþór Bragason 2019. It measured 47.5m x 2.5m and approximately 1m in height. It was noticeably irregular in places along its length but was judged to likely be a man made feature by the author. Because of its E-NE orientation and close proximity to the main farmhouse area it not interpreted to be the farm boundary represented on the Túnkort from 1913 (Fig 3). It is potentially an older or younger boundary than this. For now it remains undated. This feature has low/medium archaeological value.

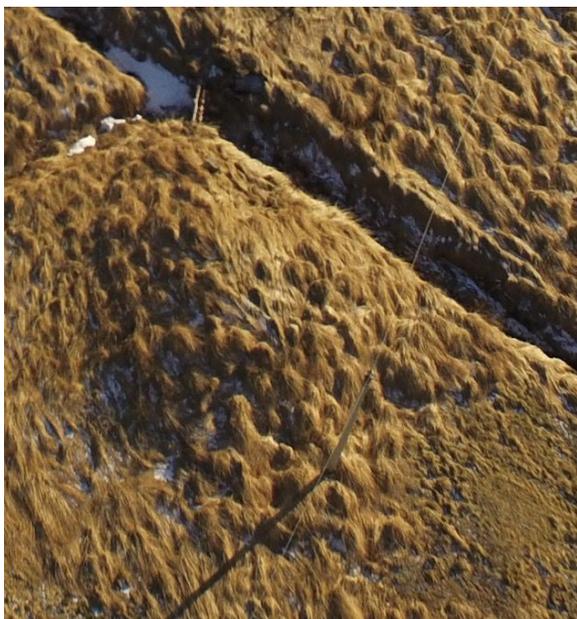
Fig 10. 2016:3 survey with scale (KM 2019)

Fig 11. 2016:3 aerial image (KM 2019)

2016:3 was identified by as a mound of stones which had been previously cleared from an old building on the farmland back in the 1950's - 'Grjóthrúga' pers. comm. Sigþór Bragason 2019. . A number of angular large stones were visible in the mound during the inspection but only further archaeological testing would determine the exact nature/dating of the feature. It measured approximately 11m x 12.5m and was 1,5m in height. This feature has low archaeological value.

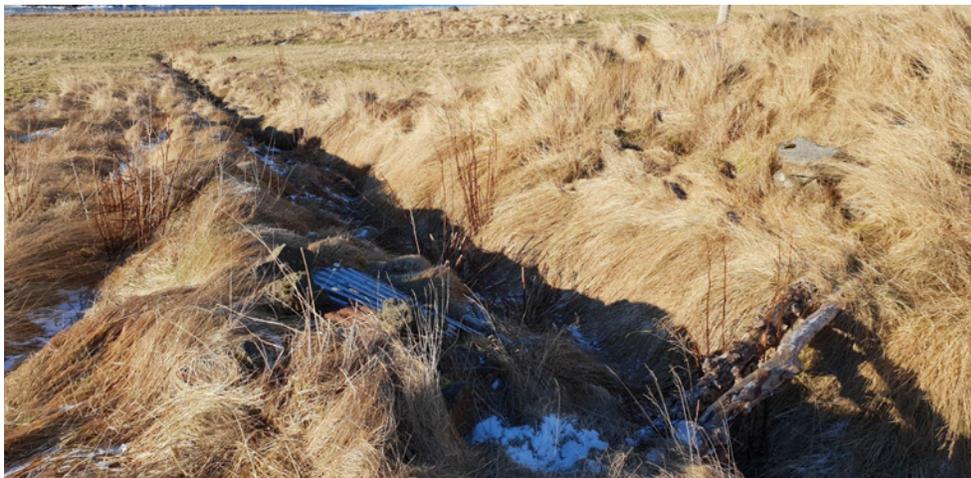
2016:4 - E:332336, N:508285

Fig 12. 2016:4 survey with scale (KM 2019)

Fig 13. 2016:4 image of feature (KM 2019)

2016:4 was identified as a mound of stones which had been cleared from an old building on the farmland back in the 1950's and is most likely connected with 2016:3 - 'Grjóthréga' pers. comm. Sigbór Bragason 2019. . A number of angular large stones were visible in the mound during the inspection but only archaeological testing would determine the exact nature of the feature. It measured approximately 2.9m x 2m and was approx 0.7m in height. This feature has low archaeological value.

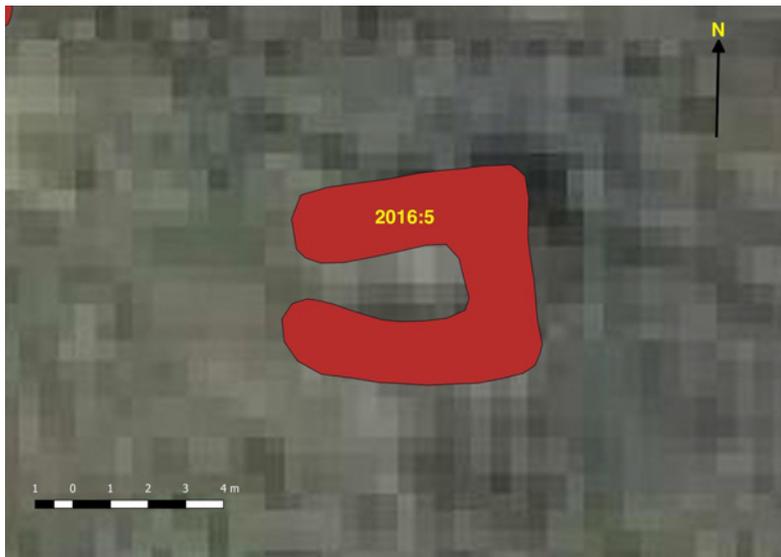
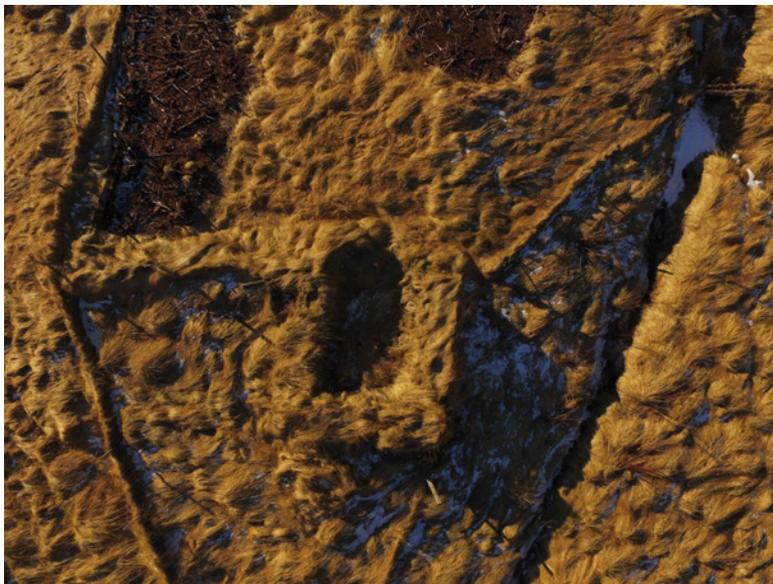
2016:5 - E:332348, N:508276

Fig 14. 2016:5 survey with scale (KM 2019)

Fig 15. 2016:5 aerial image (KM 2019)

2016:5 was identified as the remains of a former animal pen built to house a bull during the 1940's/50's. The walls were of dry stone and they survived up to 5 courses in height measuring 1.30m and 1m in width. It had an internal width of 4m x 2.4m. The landowner described it as a 'Kofi hlaðinn var utan um naut.' pers. comm. Sigþór Bragason 2019. This feature has low archaeological value.

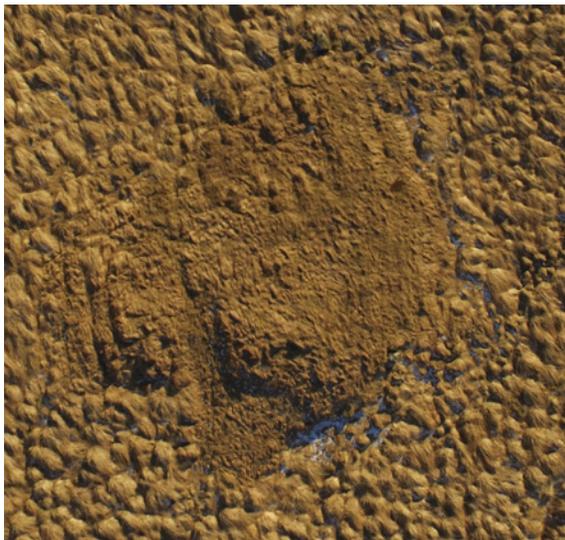
2016:6 - E:332362, N:508236

Fig 16. 2016:6 survey with scale (KM 2019)

Fig 17. 2016:6 aerial image (KM 2019)

2016:6 was identified as a mound of stones which had been cleared from an old building on the farmland back in the 1950's and is most likely connected with 2016:3/4 - 'Grjóthrúga' pers. comm. Sigþór Bragason 2019. It measured approximately 17.5m x 18m and was approx 1m in height. Only archaeological testing would determine the exact nature/dating of the feature. This feature has low archaeological value.

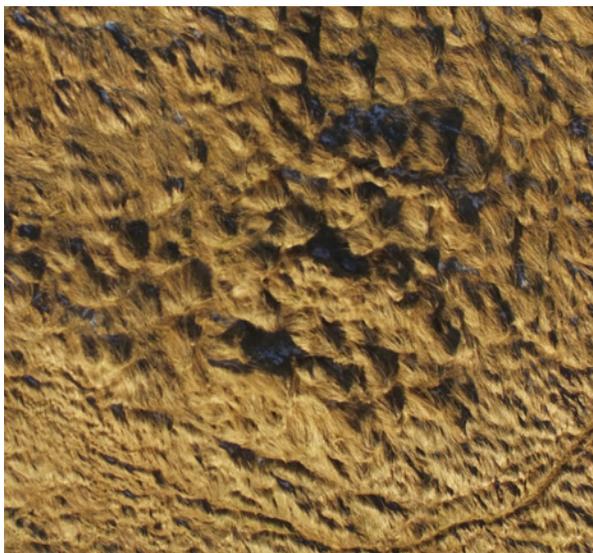
2016:7 - E:332379, N:508179

Fig 18. 2016:7 survey with scale (KM 2019)

Fig 19. 2016:7 aerial image (KM 2019)

2016:7 was identified as the remains of hesthús built during the 1950's - pers. comm. Sigþór Bragason 2019. It measured approximately 6m x 6m and was approx 1m in height. A small portion of dry stone wall survives within the feature. Only archaeological testing would determine the exact nature of the feature. This feature has low archaeological value.

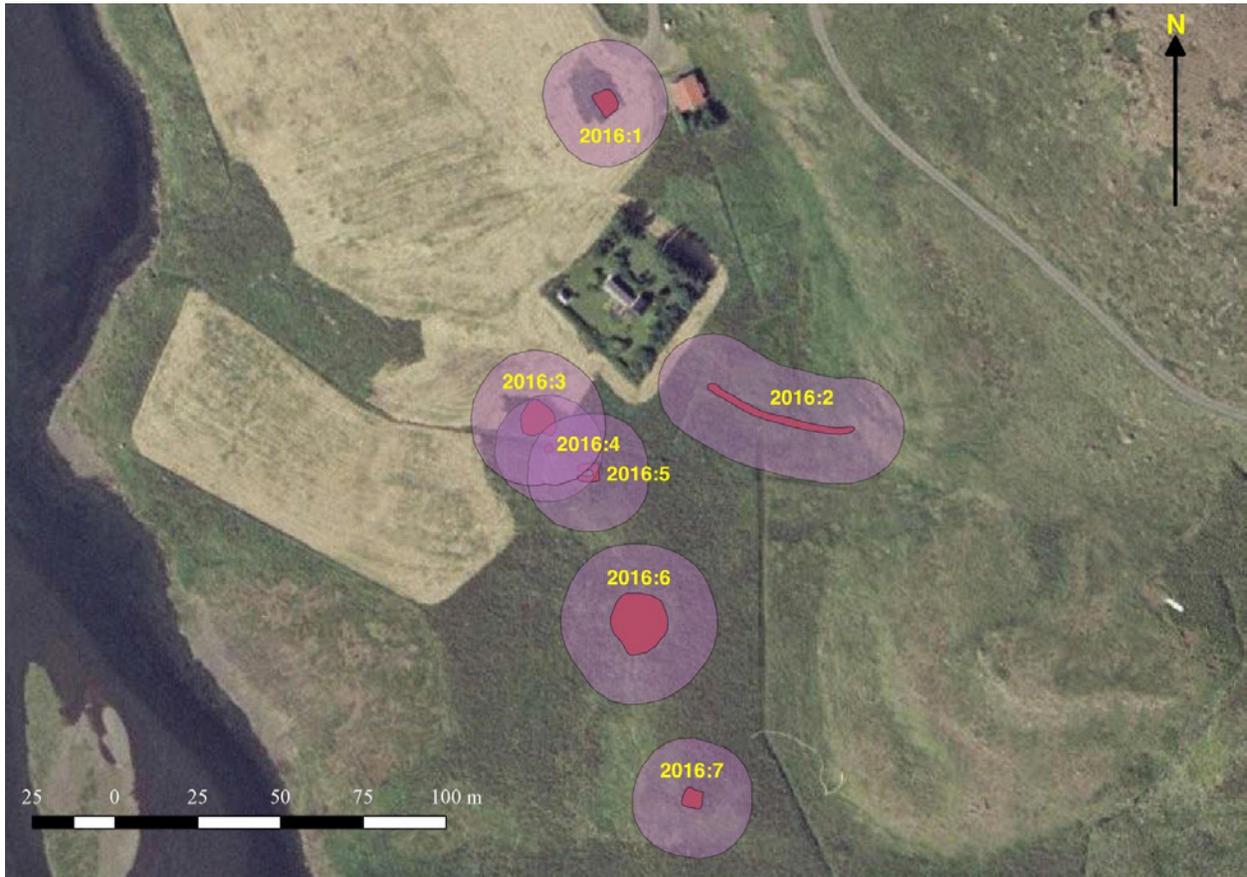
According to the Icelandic heritage legislation (menningarminjar nr. 80, 2012) a buffer/protection zone of 15m needs to be maintained around an archaeological feature which is older than 100yrs (See Fig 21, 22). The archaeological value of the seven features has been assessed by the author and 2016:1 stands out from the other features as being of medium/high archaeological value. The other six features 2016:2-6 have been categorised as low archaeological value. It is recommended therefore that any development works at Ós proposed

Fig 21. Features identified during 2019 archaeological survey of Ós with 15m protection zone indicated (K Martin 2019)

within 15m of each feature identified in this 2019 archaeological survey which potentially impacts them should be agreed in advance with Minjavörður vesturlands before they are due take place.

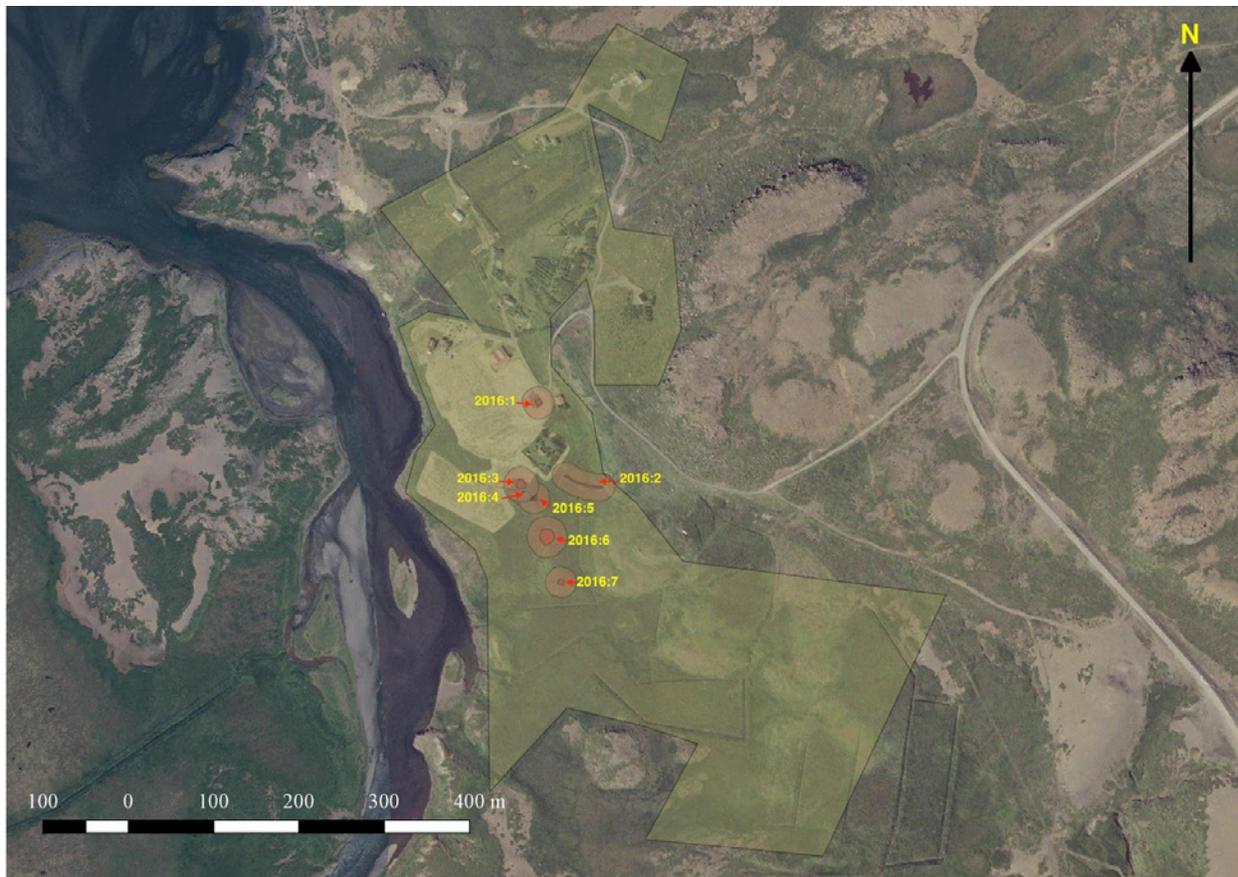
Fig 22. Features identified during 2019 archaeological survey of Ós with 15m protection zone indicated within overall development plan (K Martin 2019)
