# Investigating the Underwater Archaeological potential of the Danish Trade Monopoly Period – Grundarfjörður Trade Port 2023

Results of a side-scan sonar survey and target inspection

Report author: Dr Kevin Martin  
Minjastofnun Íslands rannsóknarleyfið: 202303-0133  
Survey No: 3169  
November 2023

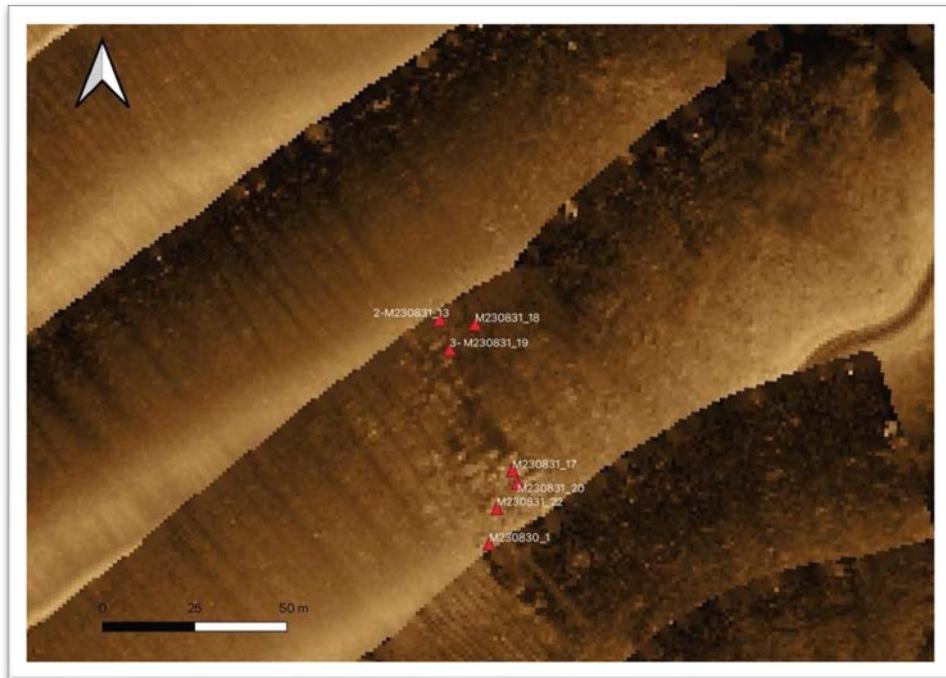
Figure 8. Cluster of sonar targets investigated during Dive 1

Dive 1 was organised so that two marine archaeologists (Dr Kevin Martin & Dr Philipp Grassel) were dropped together into the water directly over target M230831\_13 from where they swam south underwater towards target M230830\_1 where they were retrieved by the surface support vessel after completing their dive. The purpose of the dive in addition to the specific target examination was to get a general sense of the bottom composition and sedimentation of the seabed and to access visibility and currents in the water. All 7 targets inspected on this dive comprised natural geological features mostly consisting of bedrock outcrops from the seabed with kelp growth (Figures 8-18). No archaeological features or deposits of cultural heritage were identified during the dive.

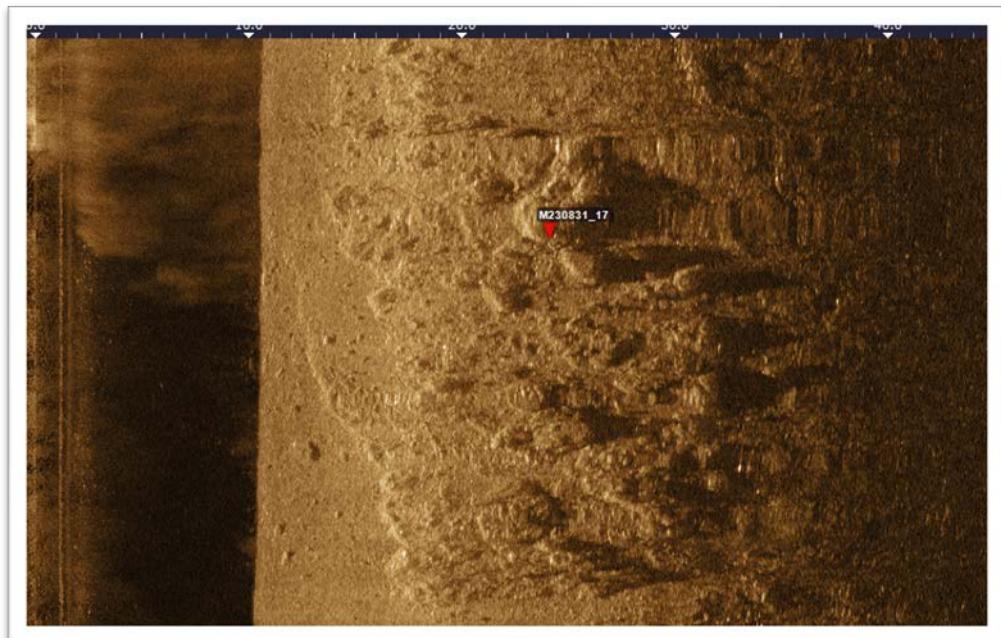
Figure 11. Close up of sonar target M230831\_17

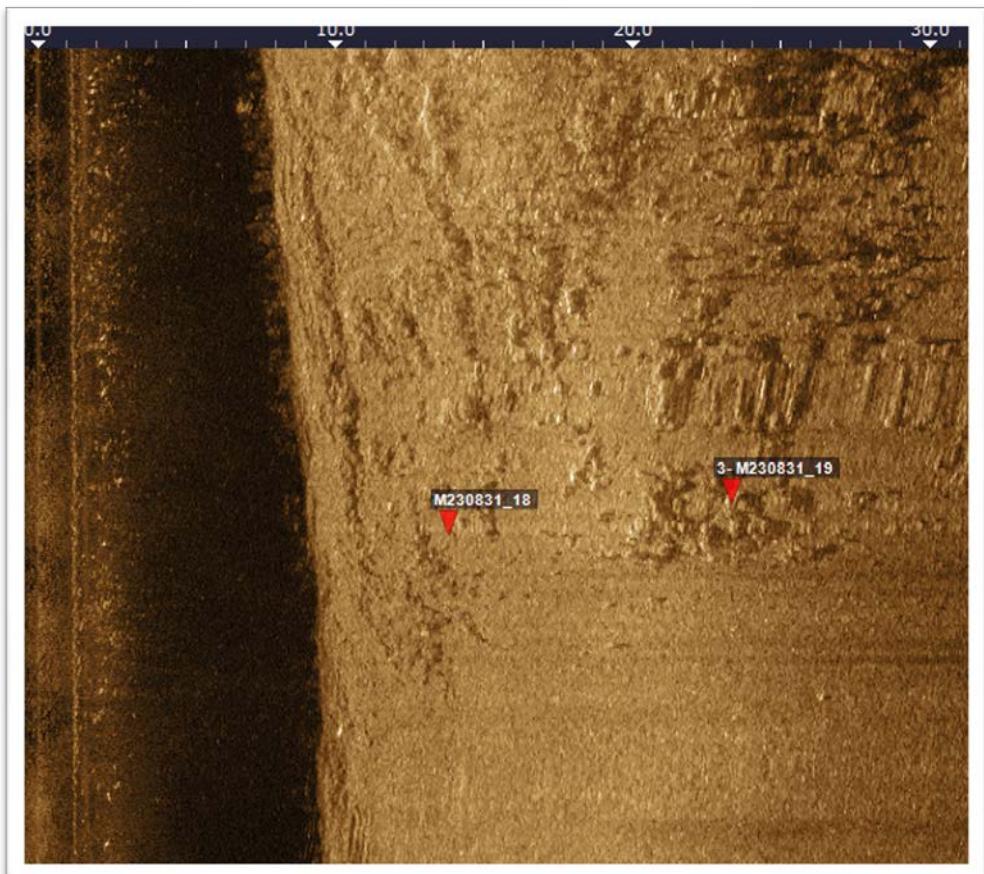
Figure 12. Close up of sonar targets M230831\_18 and M230831\_19

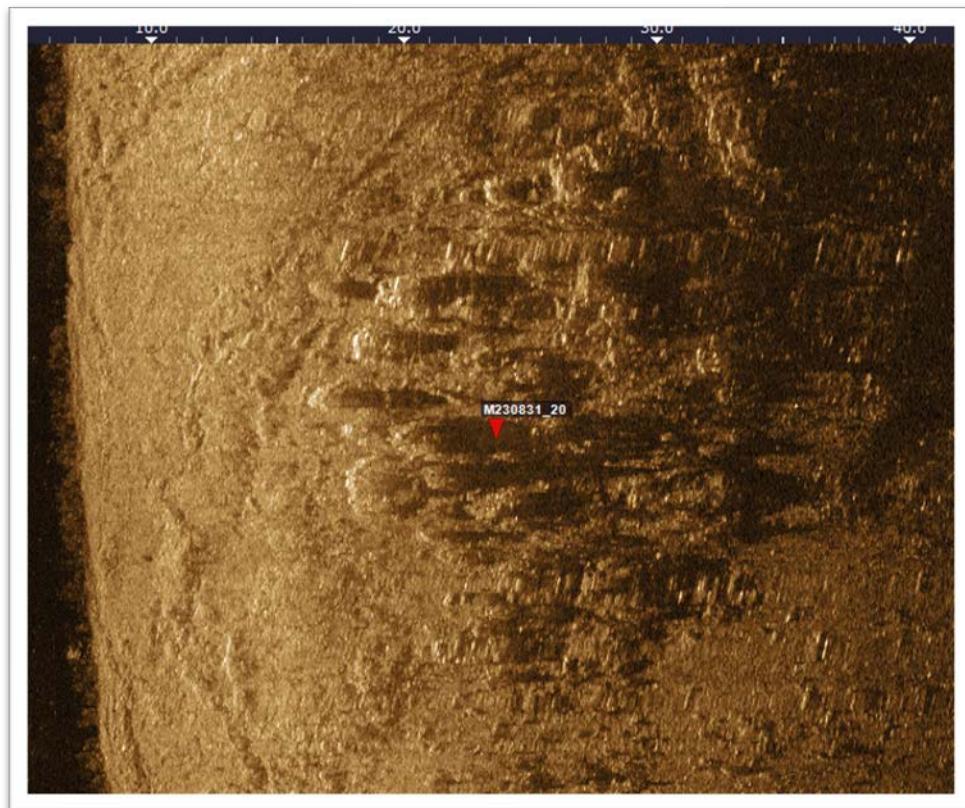
Figure 13. Close up of sonar target M230831\_20

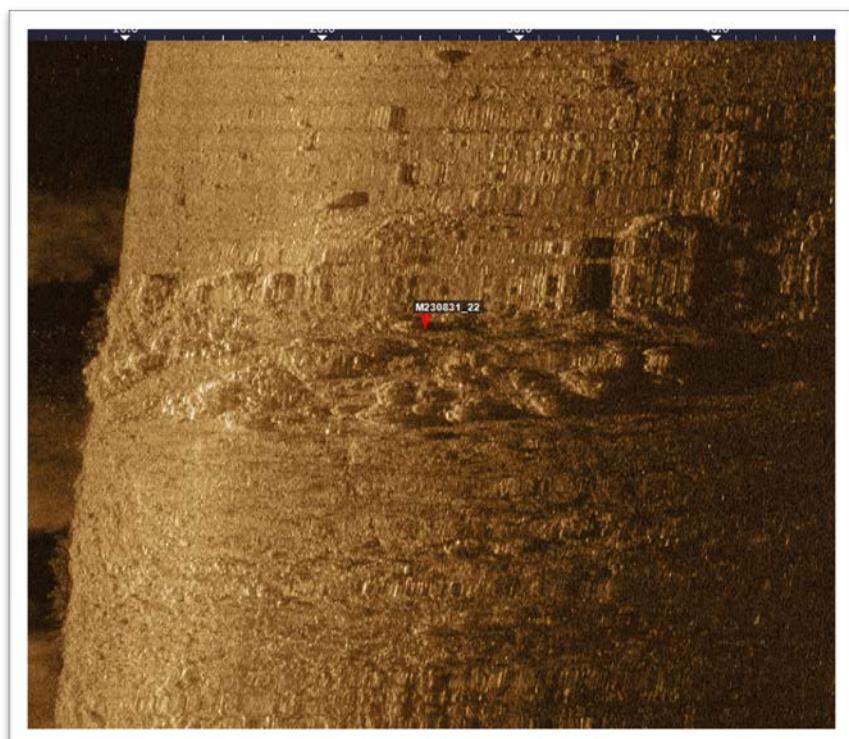
Figure 14. Close up of sonar target M230831\_22

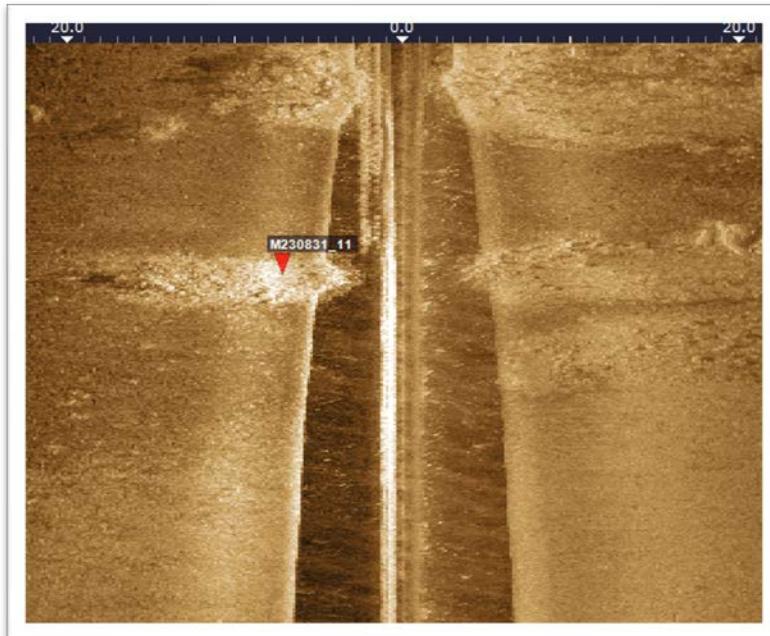
Figure 19. Close up of sonar target M230831\_11

Dive 2 was located in an area in close proximity to the modern harbour of Grundarfjörður approximately 100m east of the modern breakwater and boat harbour. There was an underwater visibility in this area of approximately 3m which was noticeably poorer than that experienced during Dive 1. The area also featured more traces of modern garbage on the seabed than was observed previously. However, this was not too surprising given its closer proximity to the modern harbour. Two targets were inspected during this dive: M230831\_11, M230831\_14 (Figures 19-22). The targets were 22m apart from each other. The seabed in this area was quite compact in places and comprised of compact small stones with almost no silt deposits evident. Where they were present the silt was not deeper than 20cm. The marine archaeologists descended a shot line directly onto Target M230831\_11 and once inspected swam southeast to target M230831\_14. M230831\_11 comprised a mound of large boulders (1-1.5m in diameter) with mixed inclusions of modern material including concrete blocks and iron rods. It's likely the boulders and associated material were dumped here during the construction of the breakwater. M230831\_14 was initially considered to possibly have represented a ballast mound but on inspection was of similar composition to target M230831\_11 and likely represented the same origins (dumped material during the construction of the nearby breakwater). No cultural heritage features or deposits were evident around these targets.

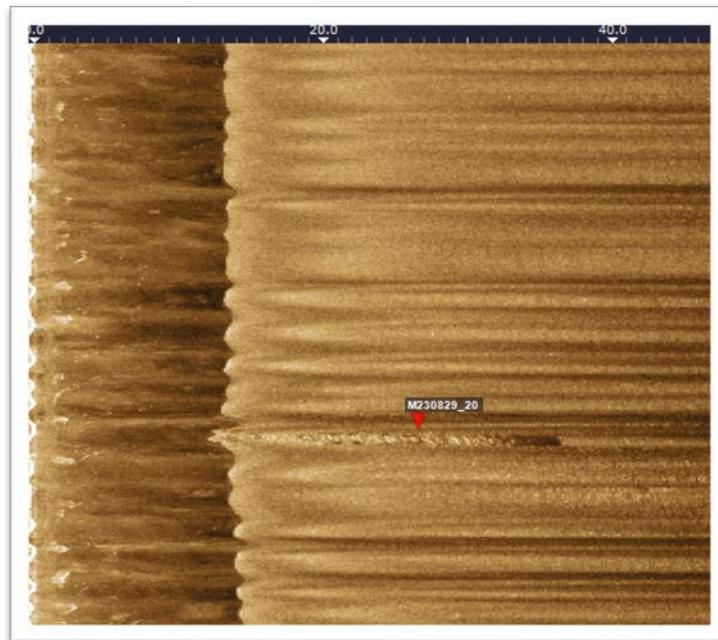
Figure 23. Close up of sonar target M230829\_20

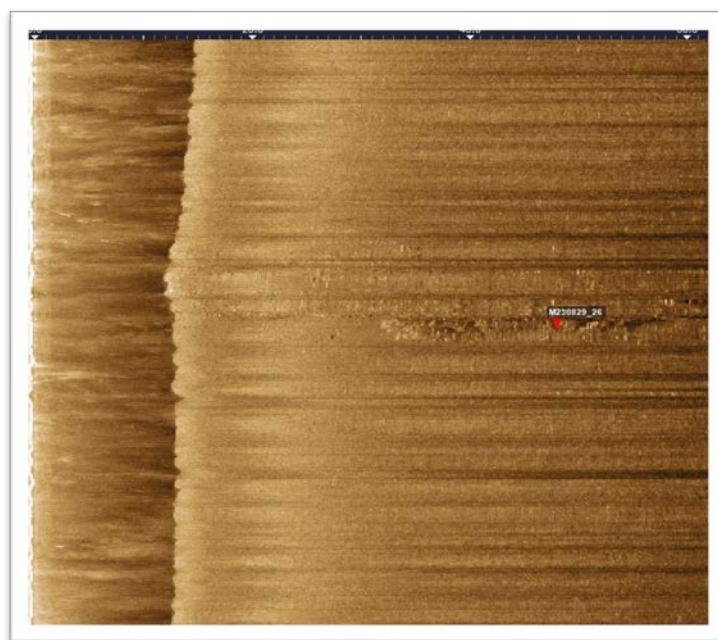
Figure 24. Close up of sonar target M230829\_26

Dive 3 was located on the northern side of the survey area approximately 1km northwest of the location area of Dive 1. Two specific targets M230829\_20 and M230829\_26 were the focus of the dive but it was considered a high potential area to dive in based on a cluster of targets localised within the same general area. There was an underwater visibility in this area of approximately 8m. Both targets were linear in form and were interpreted as potentially representing either cultural material/deposits or geological features. The targets were positioned approximately 12m apart. The seabed in this area was siltier than observed in Dives 1 & 2. The marine archaeologists descended a shot line directly onto Target M230829\_20 and this was identified as a natural geological ridge of stone along the seabed (Figure 23, 25). Once this feature was inspected the divers swam northwest to target M230829\_26 (Figure 24). This target also comprised a narrow geological ridge of stone potentially part of the same feature observed in target M230829\_20. At the south end of this stone ridge a small iron stockless or patent anchor with approximately 20m of iron chain was discovered (Figure 26-29). The chain lay directly on the seabed and ran under the sand after approximately 20m. The patent anchor lies at 11m deep.

Overall, the anchor was in reasonably good condition showing little signs of heavy corrosion or deterioration. The iron chain which was attached was more noticeably corroded than the anchor. The anchor lay directly on top of a rocky outcrop, resting upright on its flukes and was not deeply set into the seabed. All the main components of the anchor were present including flukes, shank, crown and ring. The shank was measured at 1.5m long and 0.2m thick and the flukes were approximately 0.6m high.

While this feature isn't formally protected under the Icelandic heritage legislation, if the anchor is from the Edda wreck, then it should be recognised as an important relic from a modern Icelandic tragedy at sea and protected and respected on that basis. It would be recommended that the location and position of the anchor would be shared with the harbour master in Grundarfjörður so that modern boat traffic, in particular that from any visiting cruise ships would not anchor above or disturb its position.

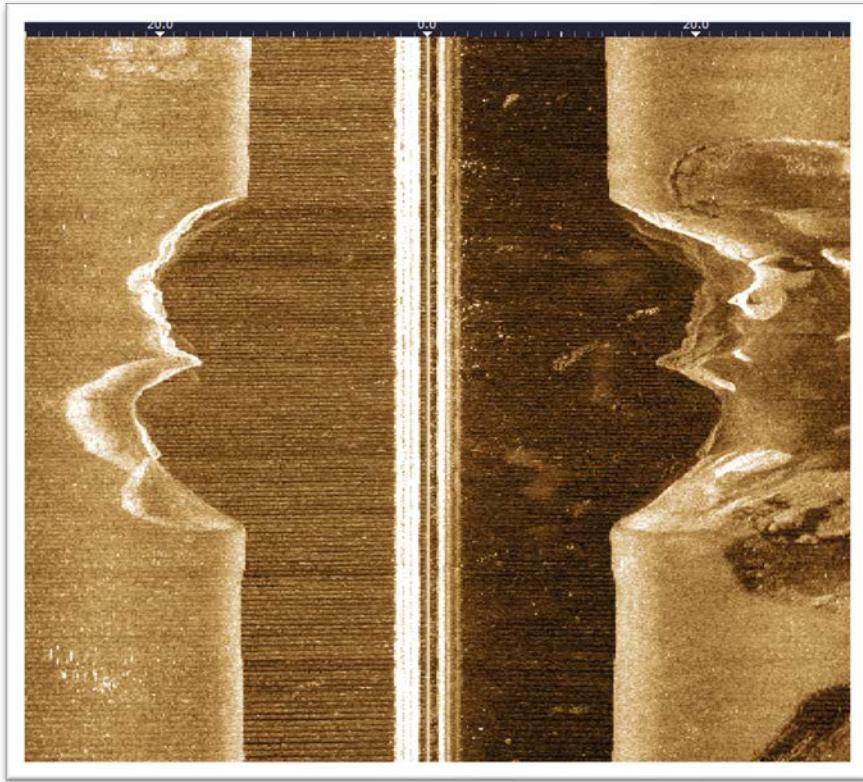
*Figure 30. Close up of sonar image of gravel extraction pits*

Dive 4 focussed on the area of the bay where gravel extraction works from the seabed had occurred during the mid-20<sup>th</sup> century. The project team had been informed by the harbour master that remains of a historic wreck had been uncovered there during gravel extraction works in the 1960's. The location was also directly in the vicinity of a known historical anchorage which was seen on a French navigational chart from 1888 (Figure 31). The anchorage is also shown on the modern Navionics chart for the bay (Figure 32). The gravel extraction pits were situated in the south eastern part of the survey area approximately 300m west of the shoreline in a depth of 20m. The visibility during the dive was limited to 2-3m and the bottom composition was a mixture of gravel under a 20-30cm layer of loose fine silt/sediment (Figure 33). The divers descended into a number of steeply sloped pits which were approximately 4-5m deep but visibility was extremely limited once any bottom sediments were disturbed. They swam over an area measuring 40m x 50m examining a number of these pits but no cultural heritage features or deposits were evident.

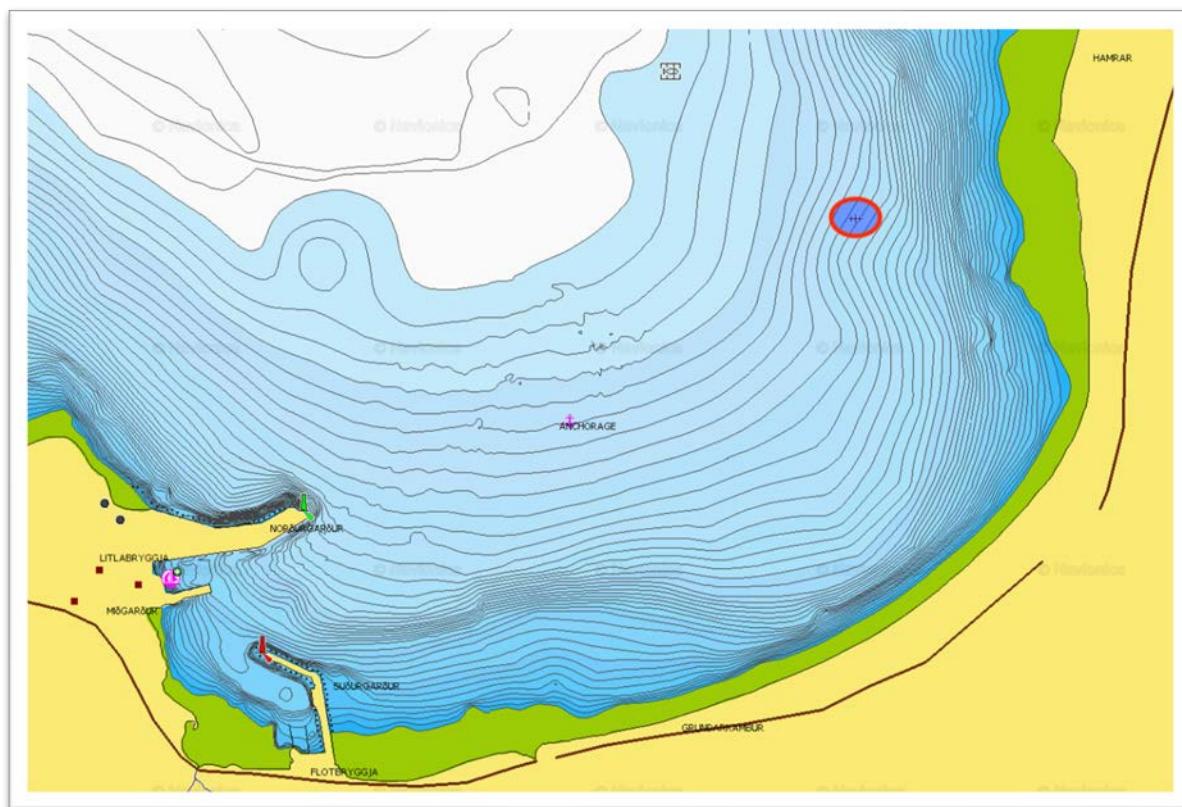
Dive 5 was located close to the eastern extent of the area of Dive 1 and was selected as a dive target based on a position marked at this approximate location on the modern navigational charts (Navionics) indicating the presence of a wreck site (Figure 34). It was also in the general area of a known historic anchorage position marked on a French navigational chart of Grundarfjörður from 1888 which the archaeological team had examined previously at a museum in the town. The depth in this area was 20m and a recorded visibility of 5m. The seabed composition in this area was a mixture of bedrock with patches of compact gravel, silt and sediment (Figure 35). A circular search was conducted but no evidence of a wreck or other cultural heritage features or deposits were evident during this dive.

Figure 34. Navionics sea chart of Grundarfjörður with the position of a wreck marked (Navionics 2023)

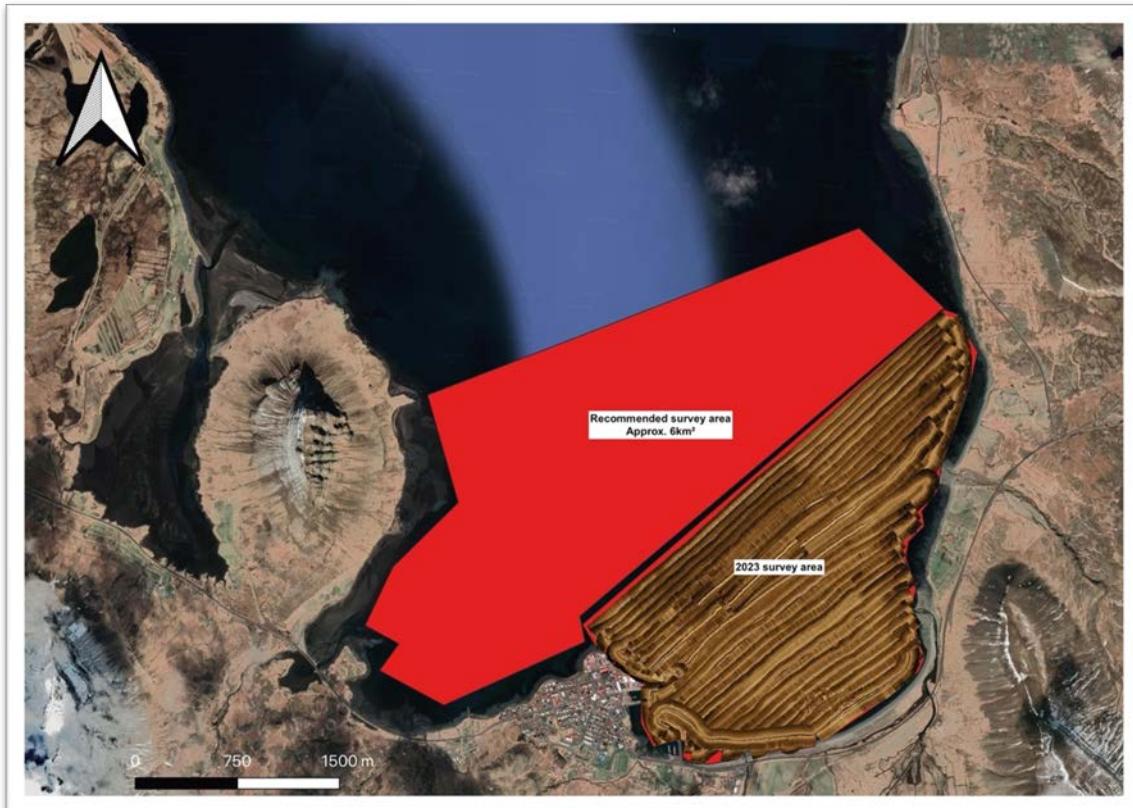
Figure 37. Recommended sonar survey area (in red) for future underwater assessment project (KM 2023)

In terms of the remaining sonar targets identified there is a total of 22 targets of potential archaeological interest which would be recommended to investigate and confirm further by diving inspection. These targets are listed below in Table 2. It is also recommended that the western half (approximately 6km<sup>2</sup>) of Grundarfjörður bay would be subject to a side-scan sonar and dive inspection survey at some point in the future to access the potential of this area for underwater cultural heritage remains (Figure 37). The areas of the sea around Melrakkaey, Vatnabúðir and Krossanes are also considered areas of submerged archaeological potential given the historical references to ships wrecking there previously (Figure 38). Further underwater archaeological survey of Grundarfjörður is advised considering the frequency of modern boat traffic which is active in the fjord particularly with regards to the arrival of multiple cruise ships during the summer months, any unknown submerged cultural heritage remains are at risk from being disturbed or damaged by anchoring vessels. It is also strongly recommended that any future gravel extraction or dredging being carried out in the bay of Grundarfjörður should be done under the supervision and in consultation with an experienced underwater archaeologist.

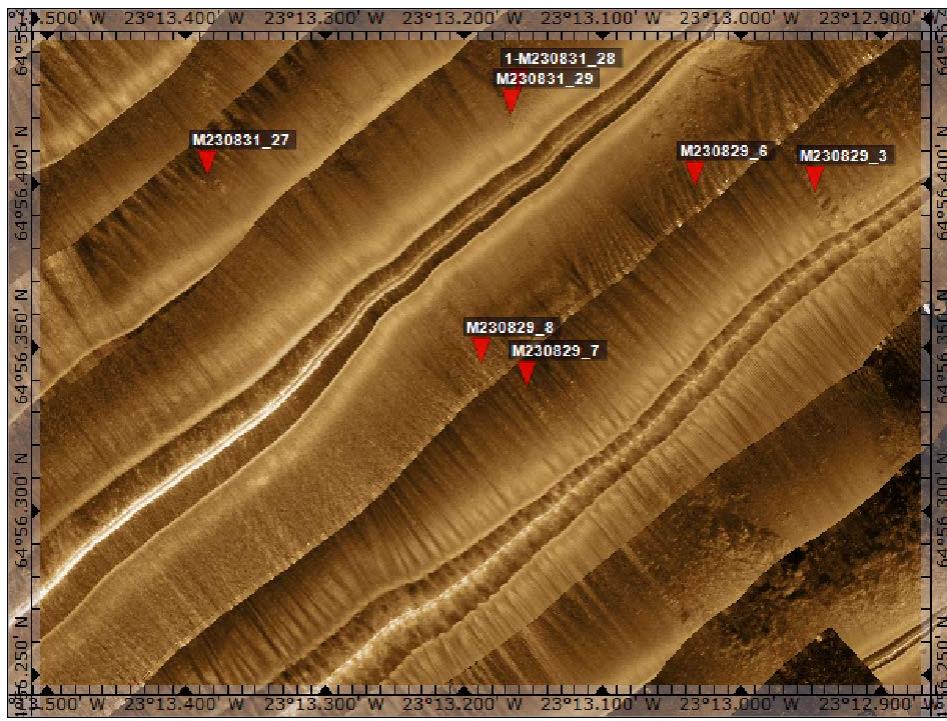
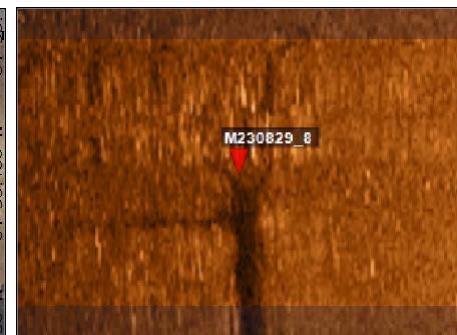
## M230829\_8

M230829_6	7 x 3.5	9	Small isolated object. May be cultural?	Recommended in future project	64° 56.398'N, 23° 13.033'W
M230829_7	25x1.5	10	Linear bed rock structure		64° 56.337'N, 23° 61.0935'W
M230829_8	7x2.5	11	Possible pit feature, natural hollow		64° 56.345'N, 23° 13.188'W
M230829_9	4x2	18	Bed rock outcrop		64° 55.776'N, 23° 14.787'W
M230829_10	15x9.1	10	Rock outcrop		64° 55.811'N, 23° 15.502'W
M230829_11	150x6	12	Linear ridge, geological		64° 56.592'N, 23° 13.782'W
M230829_12	8x5	15	Linear feature, likely natural bed rock		64° 56.578'N, 23° 13.857'W
M230829_13	20x1	15	Linear feature, possibly iron chain?	Recommended in future project	64° 56.563'N, 23° 13.836'W
M230829_14	10x4	5	Linear feature, possibly cultural?	Recommended in future project	64° 57.053'N, 23° 12.702'W
M230829_15	1.5x1	11.5	Small object, possibly rock or potential cultural feature.	Recommended in future project	64° 56.889'N, 23° 12.973'W

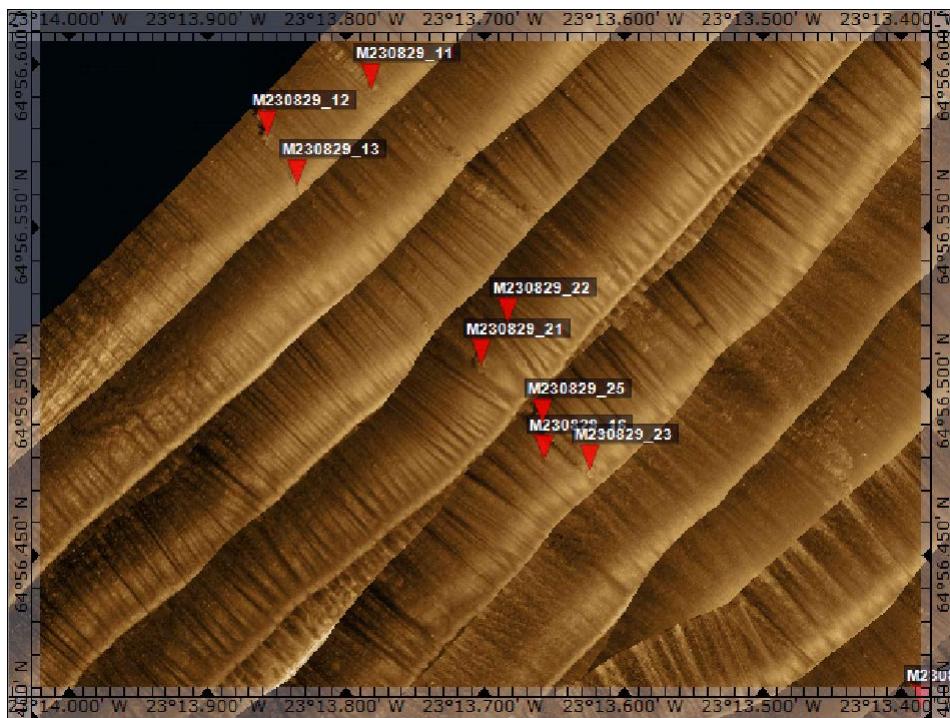
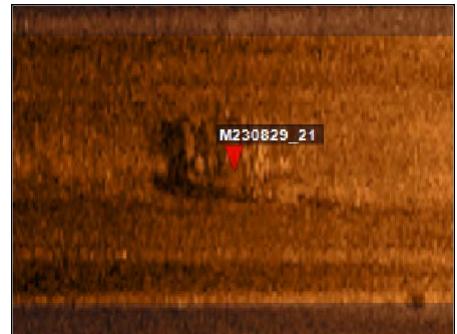
## M230829\_21

M230829_21	8x10	15	Linear ridge, likely a geological feature		64° 56.508'N, 23° 12.703'W
M230829_22	2x0.5	14.5	Linear feature, possibly timber log or part of a wreck?	Recommended in future project	64° 56.520'N, 23° 13.684'W
M230829_23	7x30	16	Linear ridge, likely geological?		64° 56.475'N, 23° 13.624'W
M230829_24	9x9	10.4	4 features, maybe modern material dumped near harbour	Recommended in future project	64° 55.724'N, 23° 15.291'W
M230829_25	18x5	15	Linear rock ridge		64° 56.489'N, 23° 13.658'W
M230829_26	40x7	14	Linear feature/ bed rock with chain and iron patent anchor	Y, Dive 3	64° 56.634'N, 23° 13.308'W
M230829_27	5x5	9	Small unknown object inside harbour, modern garbage?, potentially cultural material?	Recommended in future project	64° 55.454'N, 23° 15.093'W
M230829_28	14x1	8	Linear feature, rock outcrop		64° 56.914'N, 23° 12.673'W
Wreck location		20	Location of possible wreck from modern Sea chart / no cultural remains evident on seabed	Y, Dive 5	64° 55.983'N, 23° 13.167'W

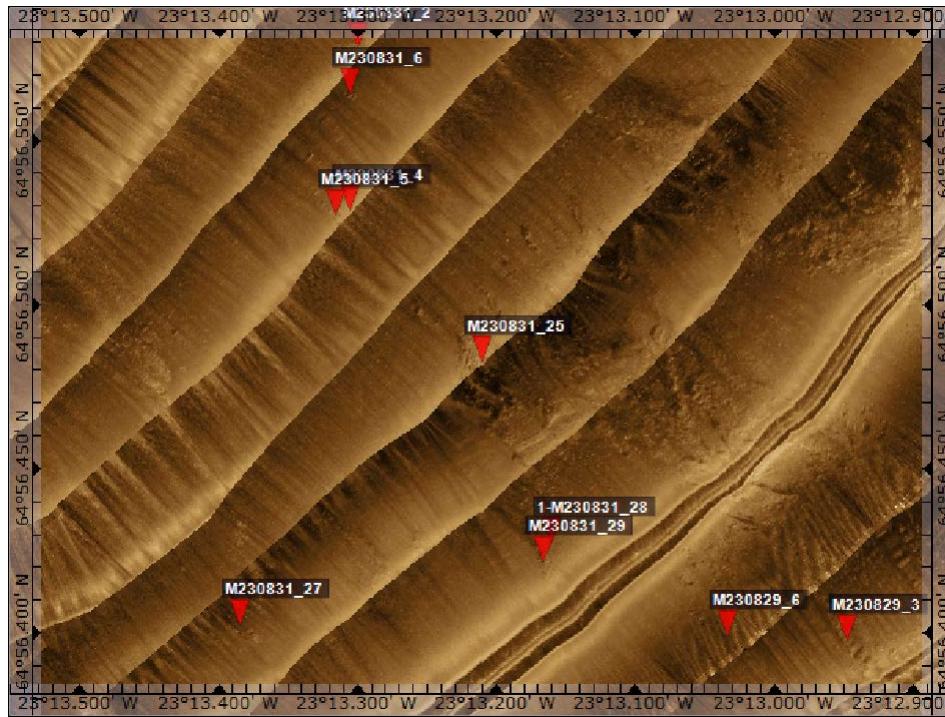
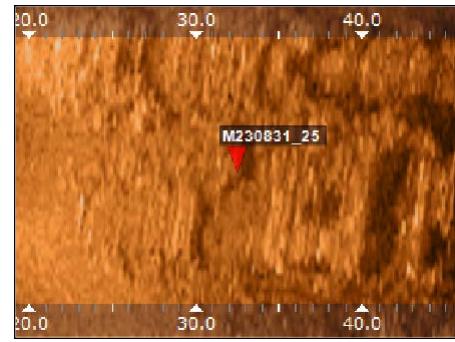
## M230831\_25

M230831_24			Invalid target		
M230831_25	10x5	10	Bedrock geological feature		64° 56.482'N, 23° 13.211'W
M230831_26	20x7	7	Rock ridge or cultural feature?	Recommended in future project	64° 56.736'N, 23° 12.757'W
M230831_27	18x6	14	Unknown feature, possibly cultural?	Recommended in future project	64° 56.402'N, 23° 13.385'W
M230831_28	30x10	11	Unknown feature, possibly cultural?	Recommended in future project	64° 56.427'N, 23° 13.160'W
Gravel pits	30x30	20	Gravel extraction pits/ no evidence of cultural remains	Dive 4	64° 55.350'N, 23° 13.380'W
